Technical Service Bulletin (TSB)
Flash: Park Assist Module (PAM) Updates

REFERENCE:	TSB: 08-123-24 REV. A GROUP: 08 - Electrical	Date:	July 18, 2024	REVISION:	08-123-24
VEHICLES AFFECTED:	2025 (DT) RAM 1500 Pickup This bulletin applies to vehicles built on or after January 02, 2024 (MDH 0102XX) and on or before April 08, 2024 (MDH 0408XX) equipped with ParkSense FR/RR Park Assist w/Stop (Sales Code XH4) and without the following systems: <ul style="list-style-type: none"> • Trailer Reverse Steering Control (TRSC) (Sales Code XA1). • Surround View Camera (SVC) System (Sales Code XAK). • Parksense Automated Parking System (Sales Code XPM). 			MARKET APPLICABILITY: <input checked="" type="checkbox"/> NA <input type="checkbox"/> MEA <input type="checkbox"/> SA <input type="checkbox"/> IAP <input type="checkbox"/> EE <input type="checkbox"/> CH	
CUSTOMER SYMPTOM:	Customers may experience the following: <ul style="list-style-type: none"> • A pop-up on the Instrument Panel Cluster (IPC) telling customer to wipe off the Park Assist Sensors (PAS), even though nothing is actually on the sensors. When this IPC pop-up is present, the front Parksense feature is disabled Fig. 1.

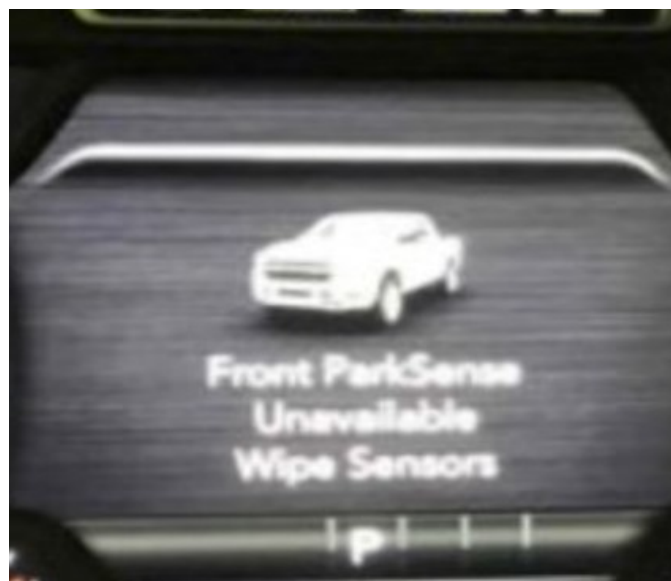
Fig. 1
IPC Message

CAUSE:	PAM software

This bulletin involves reprogramming the PAM with the latest software available.
