REFERENCE:	TSB: 08-166-24 GROUP: 08 - Electrical	Date:	July 19, 2024	REVISION:	—
VEHICLES AFFECTED:	2023 (M6) Jeep Compass 2023 (MP) Jeep Compass 2023 (MV) Jeep Compass This bulletin applies to vehicles equipped with the Surround View Camera System (Sales Code XAK).			MARKET APPLICABILITY: <div><input checked="" type="checkbox"/> NA<input type="checkbox"/> MEA</div> <div><input type="checkbox"/> SA<input checked="" type="checkbox"/> IAP</div> <div><input checked="" type="checkbox"/> EE<input type="checkbox"/> CH</div>	
CUSTOMER SYMPTOM:	Customers must experience a Malfunction Indicator Lamp (MIL) illumination and the vehicle must exhibit/set one or more of the following Diagnostic Trouble Codes (DTCs): <ul style="list-style-type: none">B2286-00 - Calibration Not Learned - Lost Calibration.B223B-00 - Vehicle Configuration Mismatch. Customers may also comment on the following: <ul style="list-style-type: none">Top-down camera view is blank when camera view is selected in the radio menu.Odometer is flashing.No backup camera gridlines when vehicle transmission is in reverse Fig. 1.

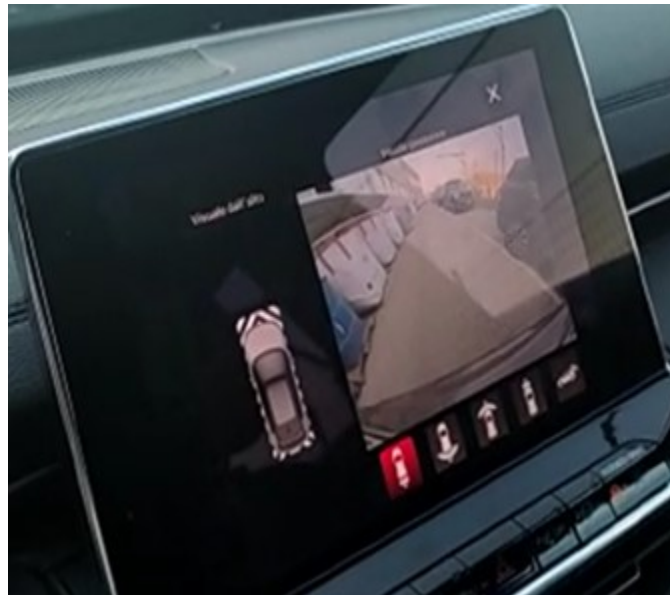
CAUSE:	CVPM software update

Fig. 1
Missing Gridlines When In Reverse Gear

This bulletin involves updating the CVPM with the latest available software.

1. Reprogram the CVPM with the latest software. If issues arise when flashing a module using the wiTECH Diagnostic Application, please submit a ticket to the Helpdesk. The helpdesk can be found within the Help menu.
2. Perform the PROXI Configuration Alignment routine located in the Guided Diagnostics menu.
3. Clear all DTCs that may have been set in any module due to reprogramming. The wiTECH application will automatically present all DTCs after the flash and allow them to be cleared.
