REFERENCE:	TSB: 08-167-24 GROUP: 08 - Electrical	Date:	July 19, 2024	REVISION:	—
VEHICLES AFFECTED:	2021 (M6) Jeep Compass 2021 (MP) Jeep Compass 2021 (MV) Jeep Compass This bulletin applies to vehicles equipped with the Surround View Camera System (Sales Code XAK).	MARKET APPLICABILITY:			
		<input checked="" type="checkbox"/> NA <input type="checkbox"/> MEA <input type="checkbox"/> SA <input checked="" type="checkbox"/> IAP <input checked="" type="checkbox"/> EE <input type="checkbox"/> CH			
CUSTOMER SYMPTOM:	<p>Customers must experience a Malfunction Indicator Lamp (MIL) illumination and the vehicle must exhibit/set one or more of the following Diagnostic Trouble Codes (DTCs):</p> <ul style="list-style-type: none"> • B2286-00 - Calibration Not Learned - Lost Calibration. • B223B-00 - Vehicle Configuration Mismatch. <p>Customers may also comment on the following:</p> <ul style="list-style-type: none"> • Top-down camera view is blank when camera view is selected in the radio menu. • Odometer is flashing. • No backup camera gridlines when vehicle transmission is in reverse Fig. 1.

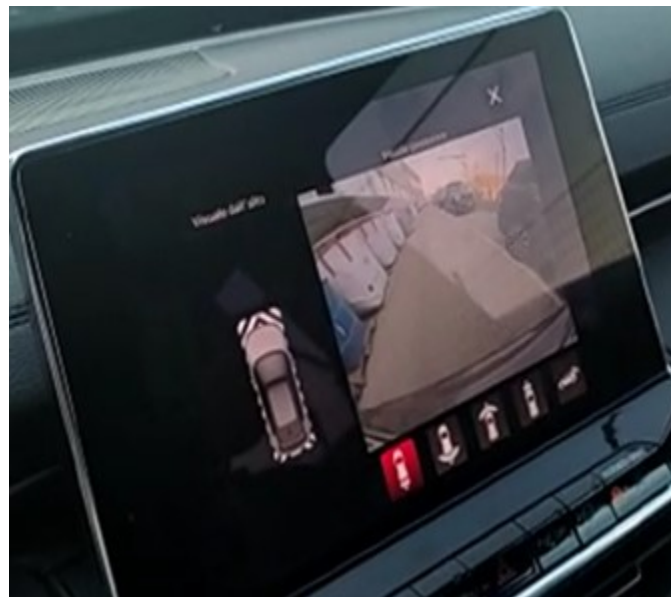
CAUSE:	CVPM software update

Fig. 1
Missing Gridlines When In Reverse Gear

This bulletin involves updating the CVPM with the latest available software.

1. Reprogram the CVPM with the latest software. If issues arise when flashing a module using the wiTECH Diagnostic Application, please submit a ticket to the Helpdesk. The helpdesk can be found within the Help menu.
2. Perform the PROXI Configuration Alignment routine located in the Guided Diagnostics menu.
3. Clear all DTCs that may have been set in any module due to reprogramming. The wiTECH application will automatically present all DTCs after the flash and allow them to be cleared.
