REFERENCE:	TSB: 08-168-24 GROUP: 08 - Electrical	Date:	July 19, 2024	REVISION:	—
VEHICLES AFFECTED:	2022 (M6) Jeep Compass 2022 (MP) Jeep Compass 2022 (MV) Jeep Compass This bulletin applies to vehicles equipped with the Surround View Camera System (Sales Code XAK).	MARKET APPLICABILITY:			
		<input checked="" type="checkbox"/> NA <input type="checkbox"/> MEA <input type="checkbox"/> SA <input checked="" type="checkbox"/> IAP <input checked="" type="checkbox"/> EE <input type="checkbox"/> CH			
CUSTOMER SYMPTOM:	<p>Customers must experience a Malfunction Indicator Lamp (MIL) illumination and the vehicle must exhibit/set one or more of the following Diagnostic Trouble Codes (DTCs):</p> <ul style="list-style-type: none"> • B2286-00 - Calibration Not Learned - Lost Calibration. • B223B-00 - Vehicle Configuration Mismatch. <p>Customers may also comment on the following:</p> <ul style="list-style-type: none"> • Top-down camera view is blank when camera view is selected in the radio menu. • Odometer is flashing. • No backup camera gridlines when vehicle transmission is in reverse Fig. 1.

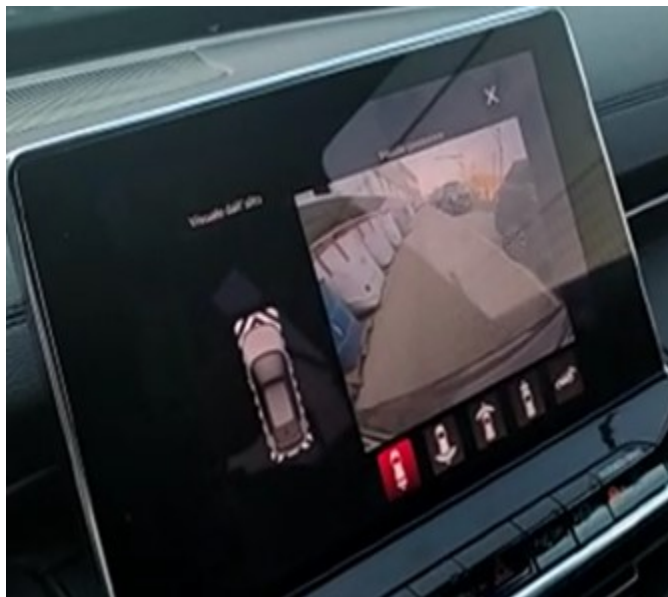
CAUSE:	CVPM software update

Fig. 1
Missing Gridlines When In Reverse Gear

This bulletin involves updating the CVPM with the latest available software.

1. Reprogram the CVPM with the latest software. If issues arise when flashing a module using the wiTECH Diagnostic Application, please submit a ticket to the Helpdesk. The helpdesk can be found within the Help menu.
2. Perform the PROXI Configuration Alignment routine located in the Guided Diagnostics menu.
3. Clear all DTCs that may have been set in any module due to reprogramming. The wiTECH application will automatically present all DTCs after the flash and allow them to be cleared.
