Technical Service Bulletin (TSB)
Spark Plug Re-Gap to Resolve Misfire Symptoms

REFERENCE:	TSB: 09-016-24 GROUP: 09 - Engine	Date:	July 17, 2024	REVISION:	–
VEHICLES AFFECTED:	2023 (LA) Dodge Challenger This bulletin applies to vehicles equipped with a 6.2L V8 Supercharged HO Engine (Sales Code ESJ) or SRT Demon 170 (Sales Code AMM).	MARKET APPLICABILITY:			
		<input checked="" type="checkbox"/> NA <input type="checkbox"/> MEA <input type="checkbox"/> SA <input type="checkbox"/> IAP <input type="checkbox"/> EE <input type="checkbox"/> CH			
CUSTOMER SYMPTOM:	<p>Customers must experience a Malfunction Indicator Lamp (MIL) illumination and the vehicle must exhibit/set one or more of the following Diagnostic Trouble Codes (DTCs):</p> <ul style="list-style-type: none"> ● P0300 - Multiple Cylinder Misfire. ● P0301 - Cylinder 1 Misfire. ● P0302 - Cylinder 2 Misfire. ● P0303 - Cylinder 3 Misfire. ● P0304 - Cylinder 4 Misfire. ● P0305 - Cylinder 5 Misfire. ● P0306 - Cylinder 6 Misfire. ● P0307 - Cylinder 7 Misfire. ● P0308 - Cylinder 8 Misfire. ● P0420 - Catalyst System Efficiency Below Threshold Bank 1. ● P0430 - Catalyst System Efficiency Below Threshold Bank 2. <p>The customer may also

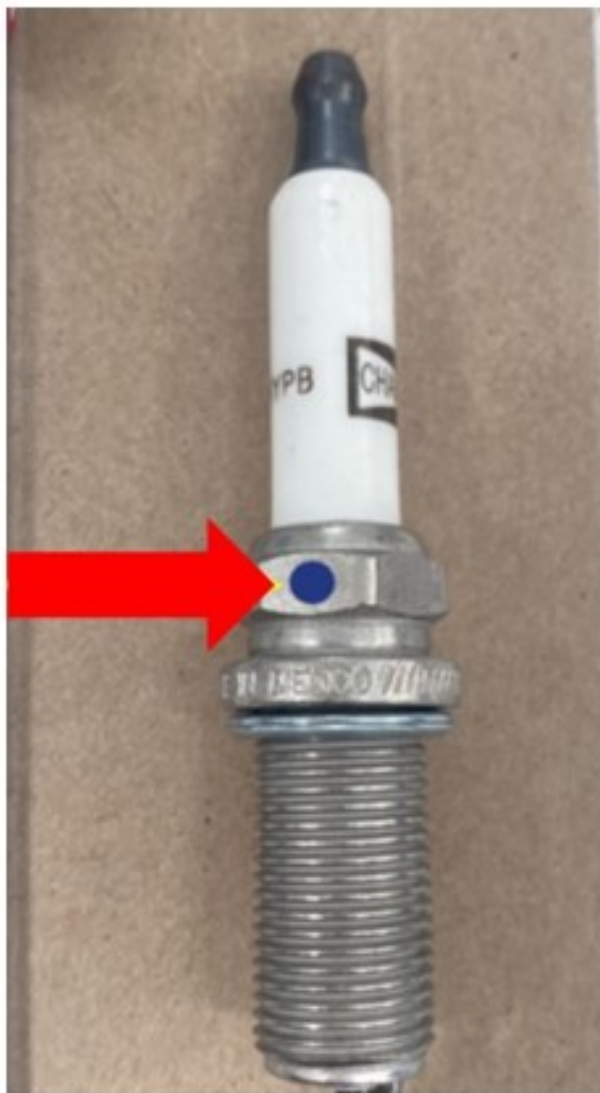
Fig. 1
Blue Mark On Re-Gapped Spark Plug

5. Using a blue paint pen, mark each spark plug that was re-gapped [Fig. 1](#).
