**DTC U010087 & No Start/ Replaced Engine ECU After Jump Starting / Replaced Engine ECU After Jump Starting**

A25A-FXS

**APPLICABLE VEHICLES**

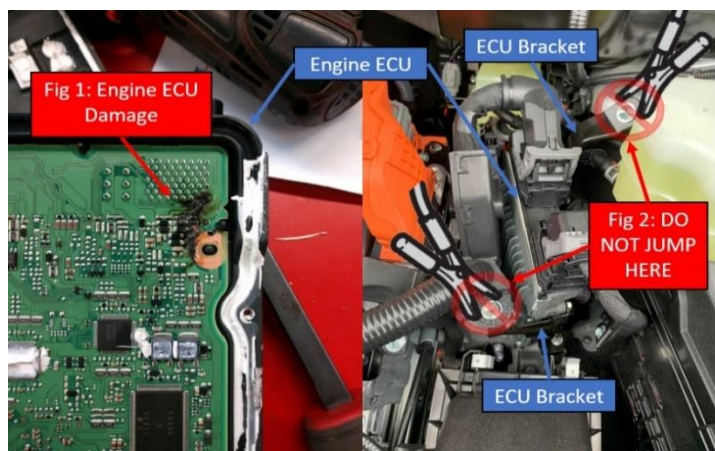
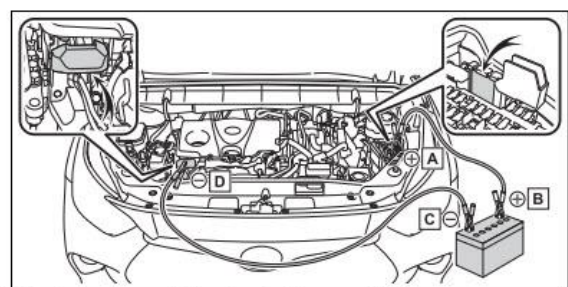
After jump-starting, the vehicle may experience a no-start condition and multiple DTCs including U010087. Upon investigation, it is found that the engine ECU has been damaged and needs to be replaced (Fig 1). In several cases, it was found that the cause of the ECU damage was improper jump starting. Further investigation found that ECU damage may occur if the negative (ground) cable clamps are attached on or around the engine ECU or ECU mounting bracket (Fig 2).

- A** Exclusive jump starting terminal (your vehicle)
- B** Positive (+) battery terminal (second vehicle)
- C** Negative (-) battery terminal (second vehicle)
- D** Solid, stationary, unpainted metallic point away from the exclusive jump starting terminal and any moving parts as shown in the illustration

To prevent this condition from occurring, it is recommended that the jumper cables be attached as described in the owner's manual. Below is an example of the correct jump start locations for 22 MY Highlander HV (Fig 3). Please consult the appropriate owners or repair manual to confirm the correct jump start location on other models.
