# Driver's Seat Cushion Leg Adjustment Inoperative

**Service Category** Vehicle Interior

YEAR(S)	MODEL(S)	ADDITIONAL INFORMATION
2023 - 2024	Sequoia HV	
2022 - 2024	Tundra, Tundra HV

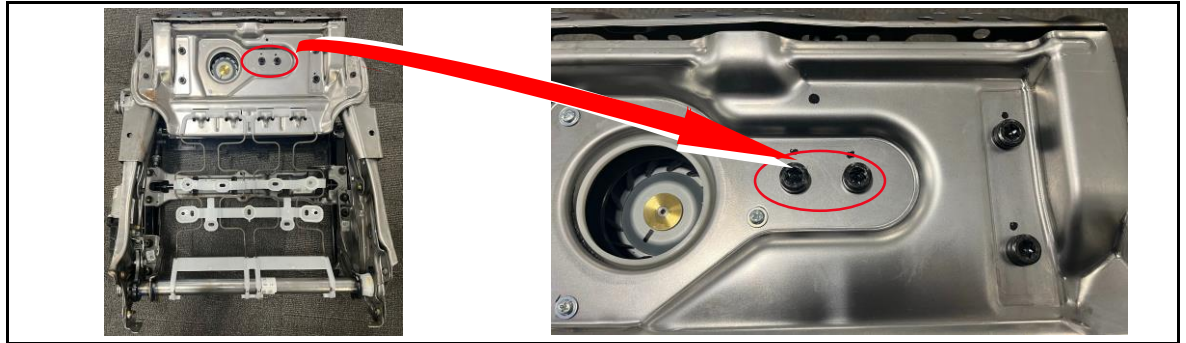
**Figure 1. Bolt Position on the Top Side of the Seat Cushion**

4. Remove the screw from the seat cushion frame.
  - A. Remove the two bolts on the top side of the seat cushion frame.

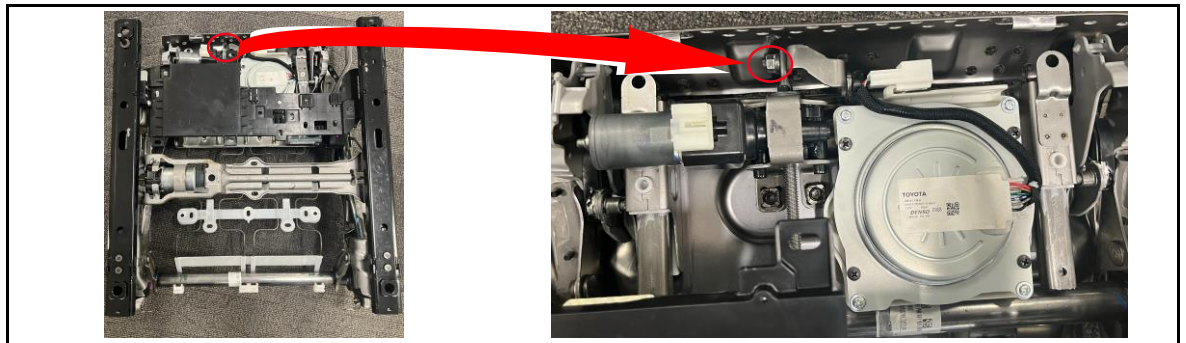
**Figure 2. Bolt Position on the Bottom Side of the Seat Cushion**

- B. Remove the bolt on the bottom side of the seat cushion frame.

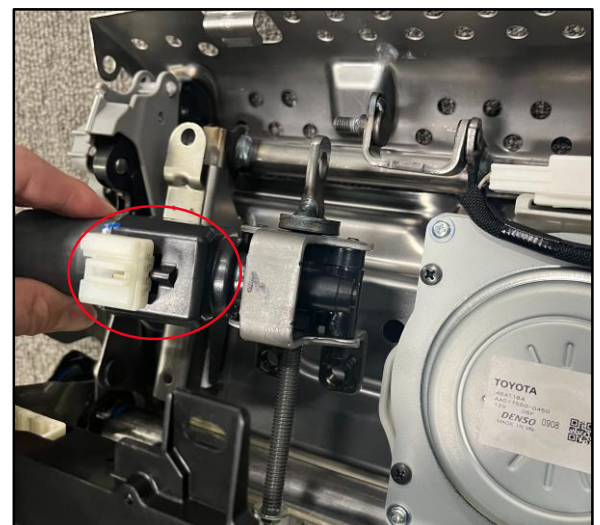
**Figure 3. The Bottom Side of the Seat Cushion**

- C. Remove the motor, that contains a screw, from the seat cushion frame.

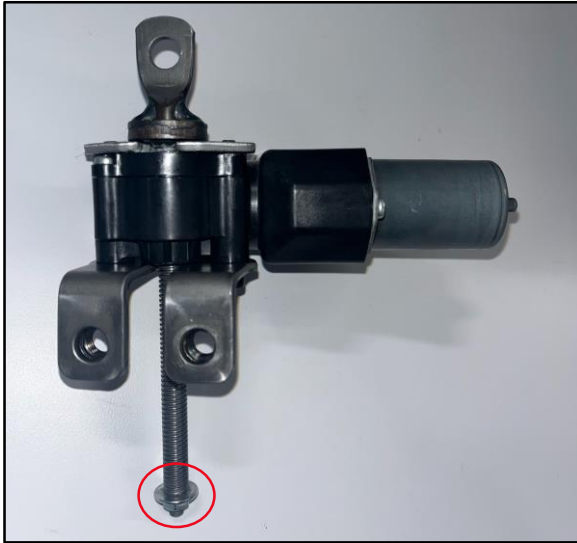
**Figure 4. Location of the Nut to Remove**

- Remove the nut on the screw.

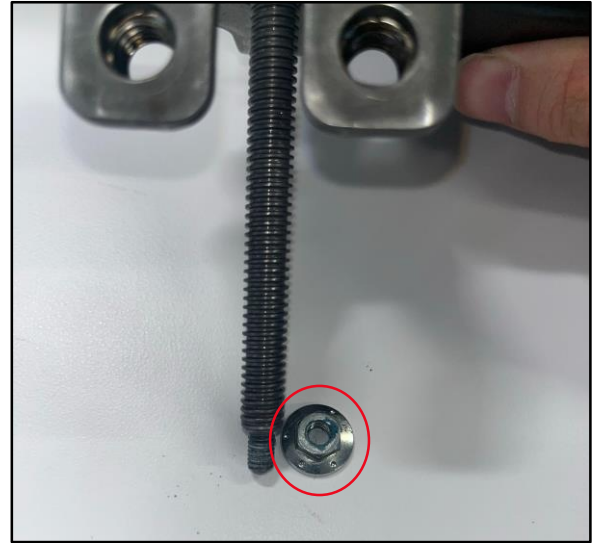
**Figure 5. Nut Removed**

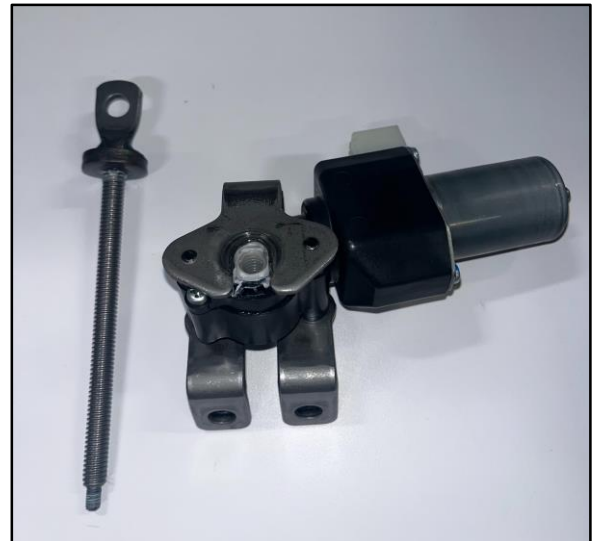
**Figure 7. Screw Removed**

- Remove the screw by turning it counterclockwise.

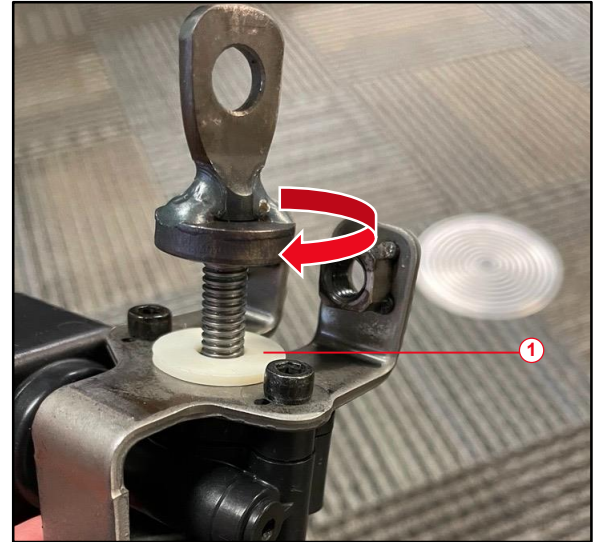
**Figure 8.**

<b>1</b>	<b>Spacer Added to Screw</b>
----------	------------------------------

7. Add a spacer to the screw, turning the screw clockwise.

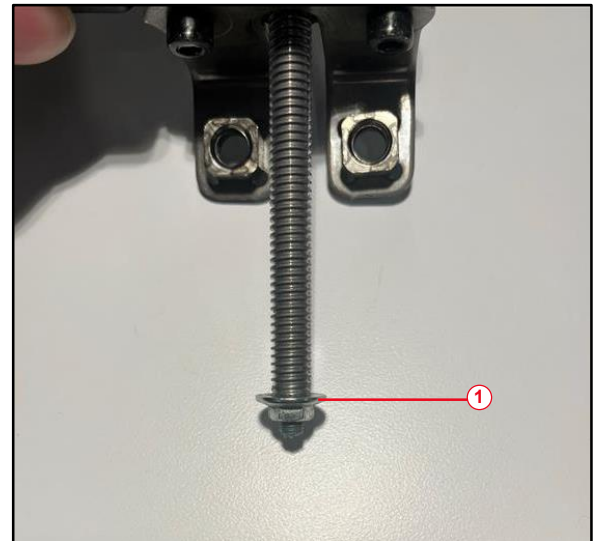
**Figure 9.**

<b>1</b>	<b>Nut Installed Onto Screw</b>
----------	---------------------------------

8. Install the nut on the screw.  
Torque: 2.45 N\*m (25.0 kgf\*cm, 21.7 in\*lb)

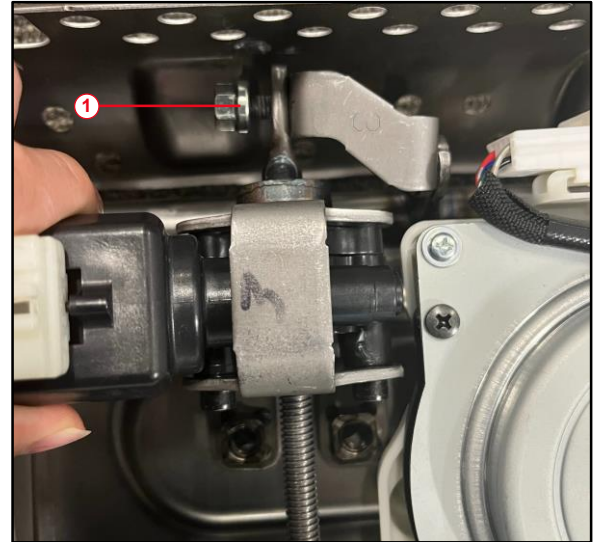
**Figure 10. Bolt Installed in the Correct Location**

<b>1</b>	<b>Bolt</b>
----------	-------------

9. Install the one bolt on the bottom side of the seat cushion frame.

**Torque: 6.5 N\*m (66.3 kgf\*cm, 57.5 in\*lb)**

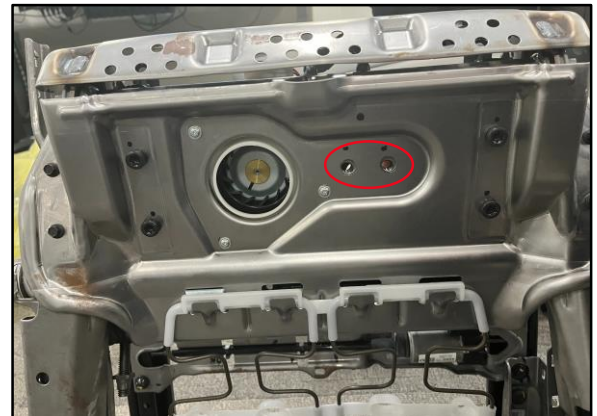
**Figure 11. Bolts Installation Location**

10. Install the two bolts on the top side of the seat cushion frame.

**Torque: 19.0N\*m (193.7 kgf\*cm, 14.0 ft\*lb)**
