# Instrument Panel Garnish Trim Loose/Detached From Dashboard

## Applicability

YEAR(S)	MODEL(S)	ADDITIONAL INFORMATION
2023 - 2024	RX350, RX350H, RX500H	WMI(s): 2T2, JTJ
2024	RX450H+	WMI(s): JTJ

## Introduction

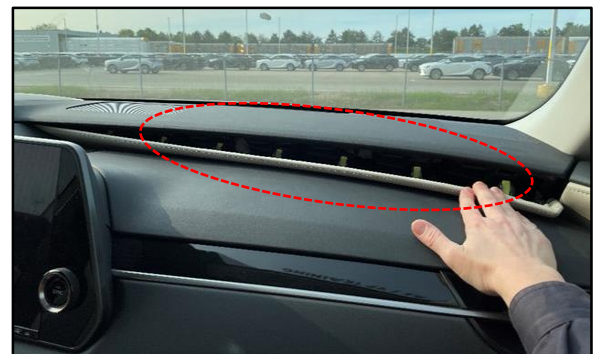
**Figure 1.**

Some 2023 – 2024 model year RX 350, RX 350h, and RX 500h and 2024 model year RX 450h+ vehicles may exhibit a condition where the instrument panel garnish trim located above the glove box becomes loose/detached from the instrument panel dashboard. This condition is more prevalent in warmer/rough terrain regions due to inadequate retention of the garnish clips. Follow the Repair Procedure in this bulletin to address this condition.

1. Confirm the condition exists.  
Does the vehicle exhibit a loose/detached garnish trim appearance as shown in Figure 1?

Poor retention is more noticeable in the center portion of the garnish trim.
