**TECHNICAL INSTRUCTIONS  
FOR  
SPECIAL SERVICE CAMPAIGN  
24TD03  
INFOTAINMENT “SERVICE” SUBMENU IS NOT VISIBLE  
CERTAIN 2022 MIRAI VEHICLES**

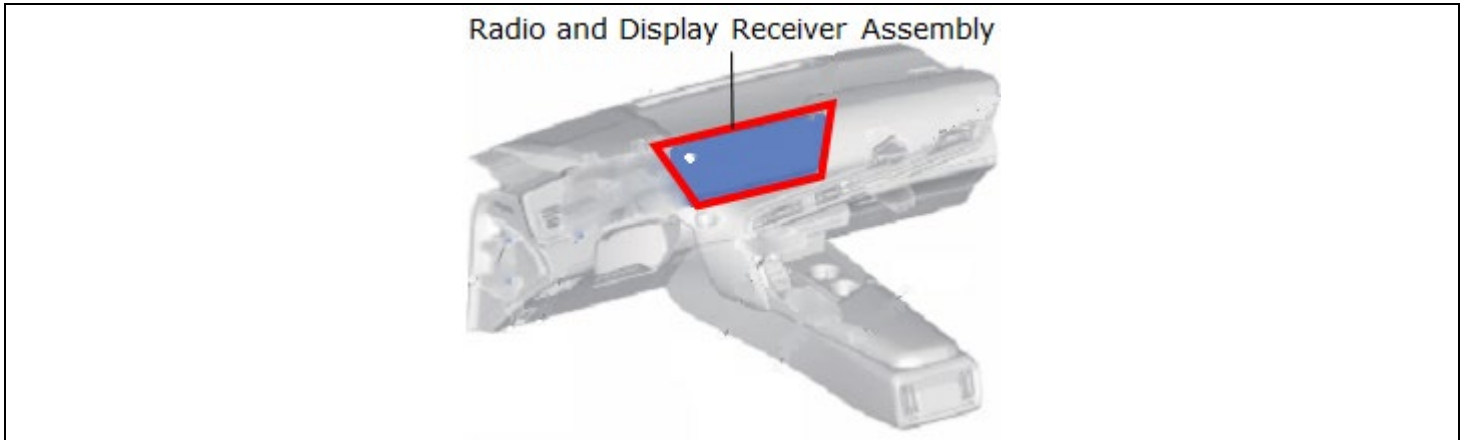
Certain vehicles may not have the infotainment app installed. If the infotainment app is not installed, the submenu (Service) is not displayed, and Over the Air (OTA) updates cannot be performed.

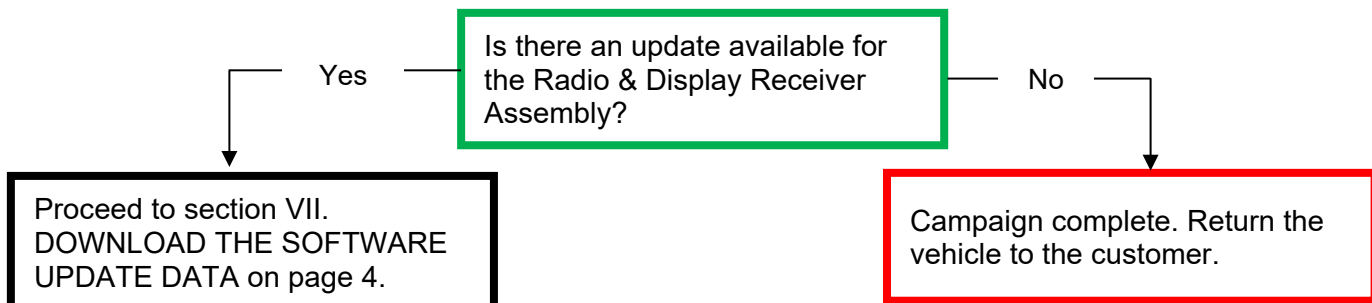
The Software Versions to update in this campaign are as shown in the table below.

Software Versions		
Item	Current Version	New Version
Audio	Less than <b>1162</b>	<b>1225</b>
