GENERAL MOTORS  
DCS6947  
URGENT - DISTRIBUTE IMMEDIATELY

Subject: N242456100- Service Update  
Body Control Module Reprogramming

Models: 2024 Chevrolet Corvette

## N242456100 Body Control Module Reprogramming

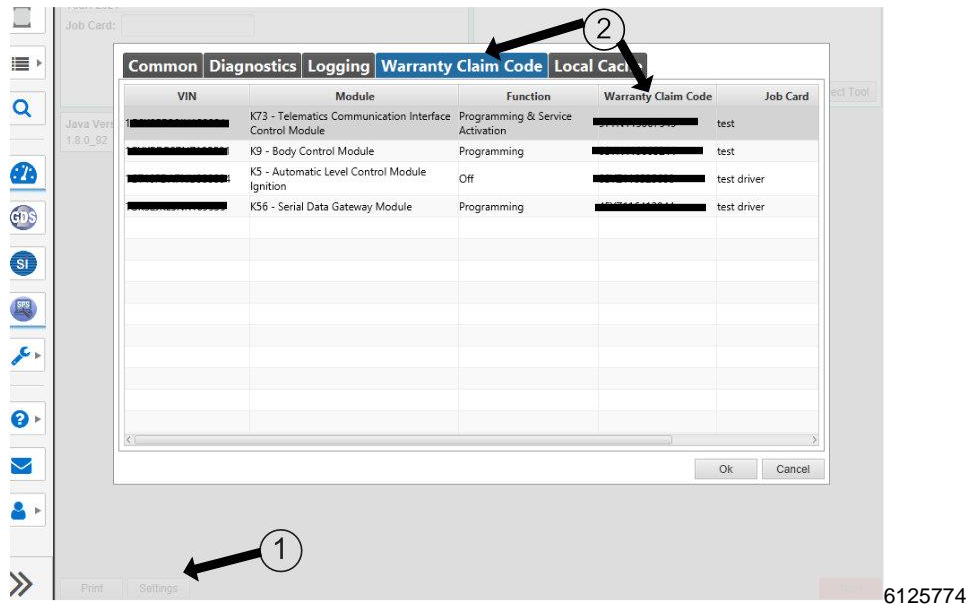
### Warranty Claim Code Information Retrieval

If the Warranty Claim Code was not recorded on the Job Card, the code can be retrieved in the SPS2 system as follows:

1. Open TLC on the computer used to program the vehicle.
2. Select and start SPS2.
3. Select Settings (1).
4. Select the Warranty Claim Code tab (2).

The VIN, Warranty Claim Code and Date/Time will be listed on a roster of recent programming events. If the code is retrievable, dealers should resubmit the transaction making sure to include the code in the SPS Warranty Claim Code field.

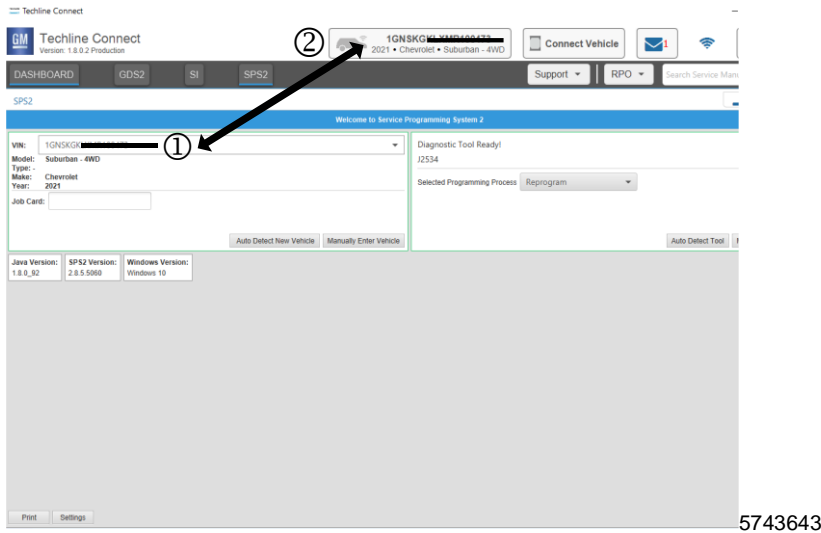
**Caution:** Be sure the VIN selected in the drop down menu (1) is the same as the vehicle connected (2) before beginning programming.

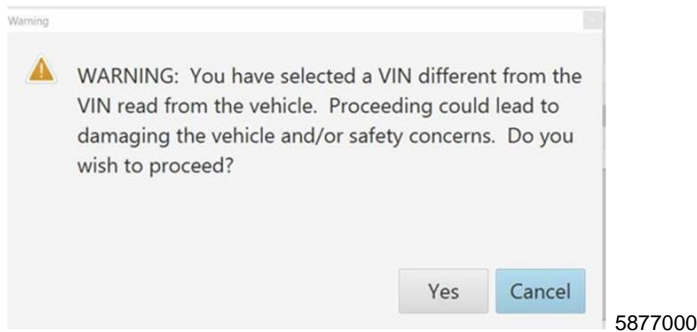
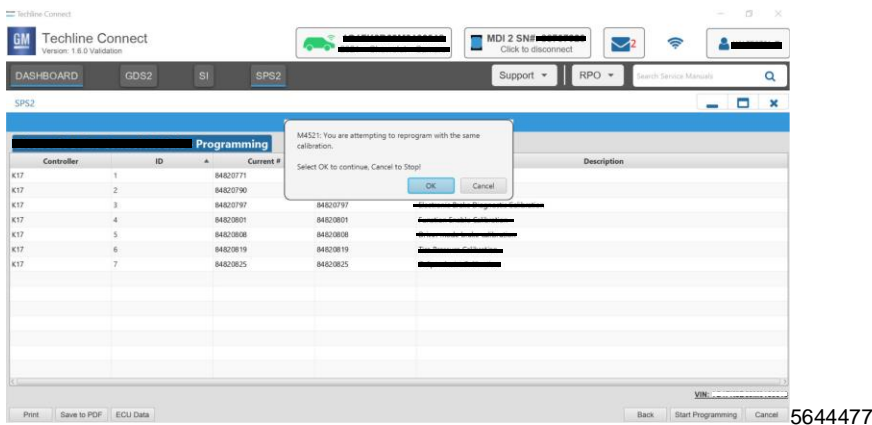
**Important:** If the vehicle VIN DOES NOT match, the message below will be shown.

- If the VIN that shows up in the TLC top center window after correctly reading the VIN from the vehicle does not match the VIN plate of the vehicle, manually type in the VIN characters from the vehicle VIN plate into the TLC top center window and use these for programming or reprogramming the subject module with the correct vehicle VIN and software and/or calibrations.

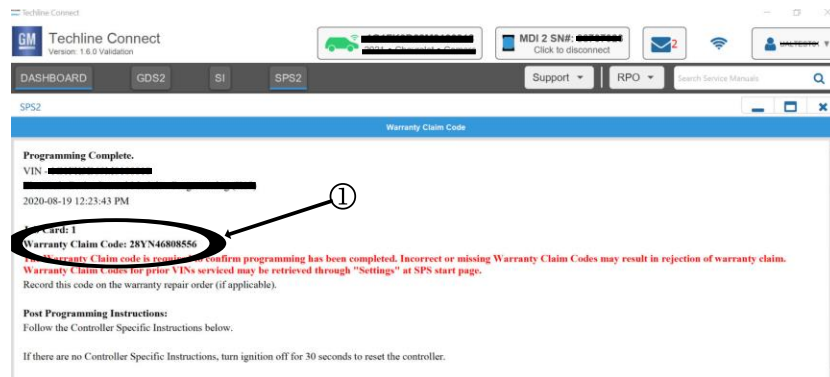
5644478

**Note:** The screenshot above is an example of module programming and may not be indicative of the specific module that is being programmed. Module selection and VIN information have been blacked out.

**Important:** To avoid warranty transaction rejections, you **MUST** record the warranty claim code provided on the Warranty Claim Code (WCC) screen shown above on the job card. Refer to callout 1 above for the location of the WCC on the screen.

1. Reprogram the K9 Body Control Module. Refer to *K9 Body Control Module: Programming and Setup* in SI.

2. Record SPS Warranty Claim Code on job card for warranty transaction submission.
