STAR ONLINE PUBLICATION

Case Number: S2425000001

Symptom/Vehicle Issue: Malfunction Indicator Lamp/Check Engine Lamp On.

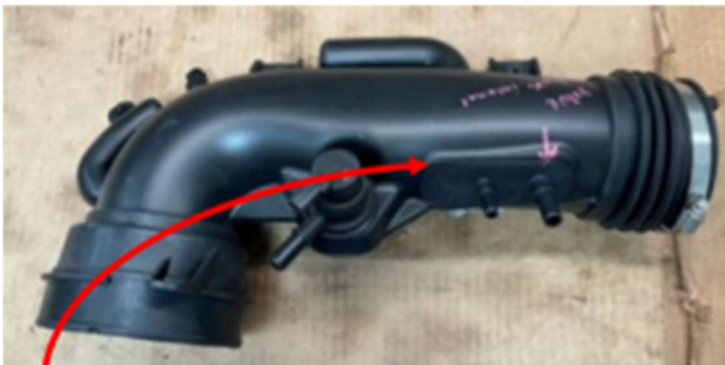
Fresh air duct

If all connections are secure, remove the fresh air duct. Using a borescope, inspect the ejector tee for melted plastic or other deformities obstructing air flow.

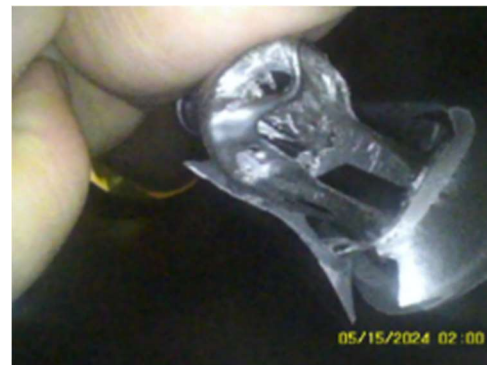
Customer Complaint/Technician Observation: Customer complaint may include MIL/CEL on with no accompanying driveability symptoms. Upon further inspection, a DTC for P1CEA - BOOST SIDE EVAP PURGE SYSTEM PERFORMANCE may be found in the Powertrain Control Module (PCM).

Melted Plastic at Ejector Tee

If obstructions are found at the ejector tee, replace fresh air duct and retest. If DTC returns, perform published diagnostic procedure for DTC.
