SIB 28 02 24

SERVICE ACTION: DOUBLE CLUTCH TRANSMISSION REWORK AT TRANSFER CASE

This Service Information Bulletin (Revision 2) replaces SI B28 02 24 **dated May 2024**.

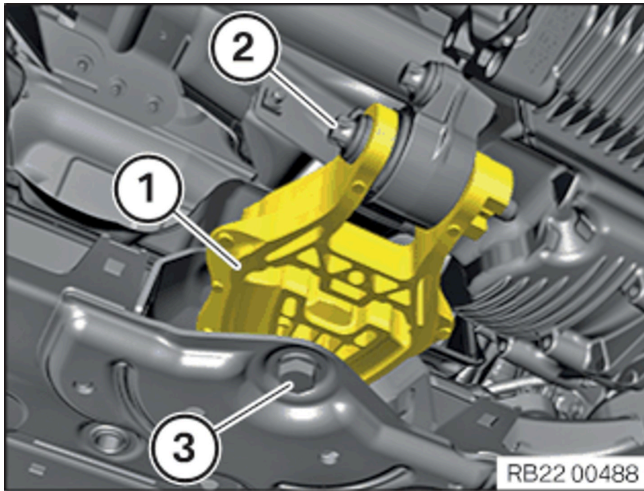
Remove the stabilizer link (1).

Reinstallation: Replace bolts 2 and 3

Tighten to 100 Nm and torque angle 90°

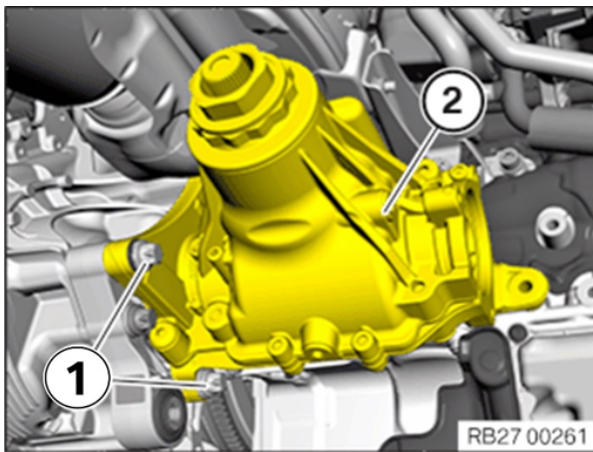
Remove the two bolts (1) on the transfer case.

Reinstallation: Replace both bolts

Tighten to 100 Nm and torque angle 90°

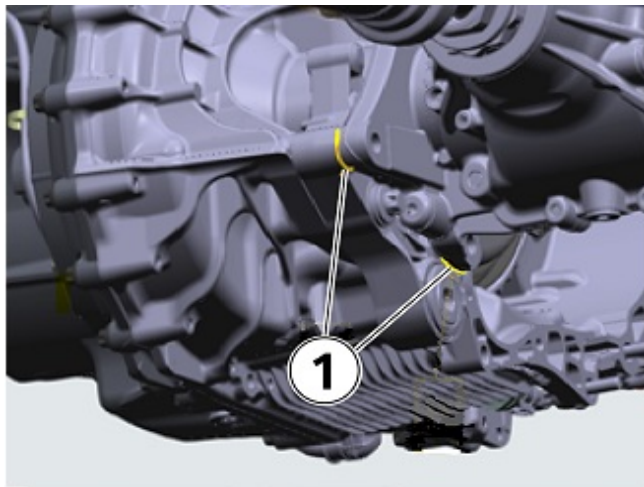
Install washers between the link and transfer case. It may be necessary to slightly push the transfer case to the side to install the washers.
