SIB 33 01 24
PROPER REPAIR PROCEDURE FOR REAR AXLE FAILURE (BEV)

2024-07-23

G26 i4 Gran Coupe Battery Electric Vehicle (BEV) With HEAT 220LR	G60 i5 Sedan (BEV)	G70 i7 Sedan (BEV)	i20 iX Sports Activity Vehicle (SAV BEV)
---	--------------------	--------------------	---

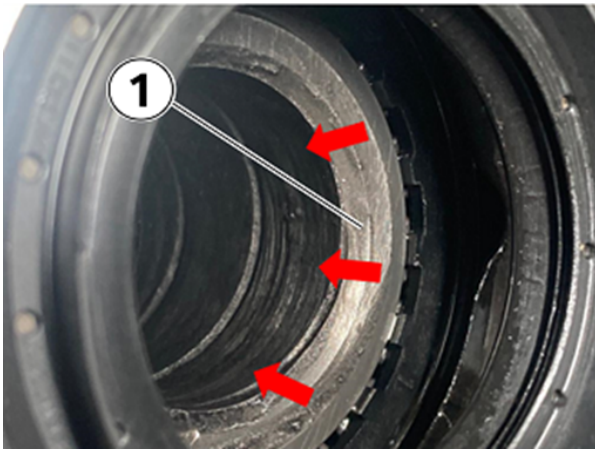
- Visually check the parallel key spline in the differential of the electric drive unit for damage (on the side where the driven shaft is broken)
- Visually check whether fragments of the driven shaft have remained in the differential
- Check the surfaces of the plain bearing seats (on both sides of the differential) for discoloration due to high heat, chips, and seizing marks (1)

If damage is found at the points listed above, the electric drive unit must be replaced.

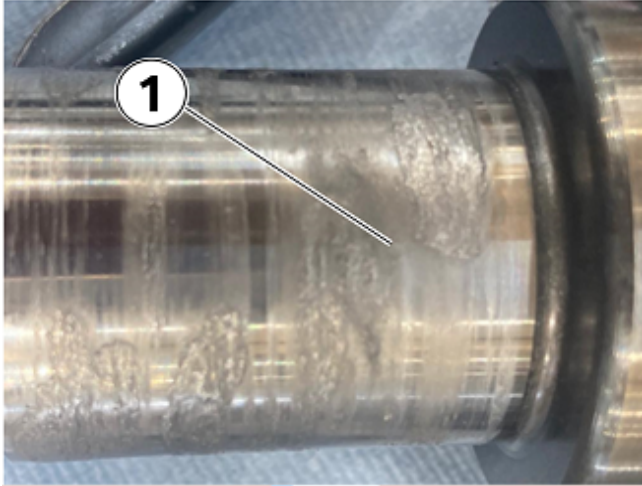
- Check the surface of the plain bearing seats of both driven shafts for discoloration due to high heat, chips, and seizing marks (1)
