SIB 51 15 24

DELIVERY STOP: PASSENGER SUN VISOR

This Service Information Bulletin (Revision 1) replaces SI B51 15 24 **dated June 2024**.

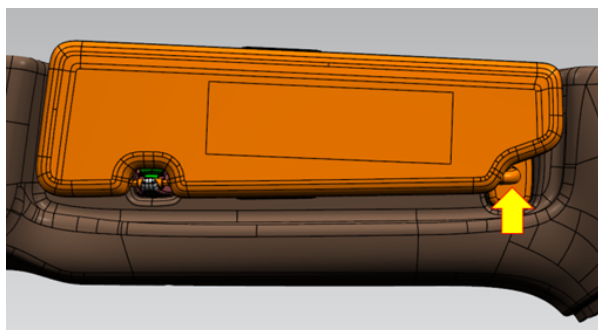
During supplier production, the passenger sun visor shaft may not have been fully pressed into the socket (arrow).

Check and if necessary, replace the passenger side sun visor.

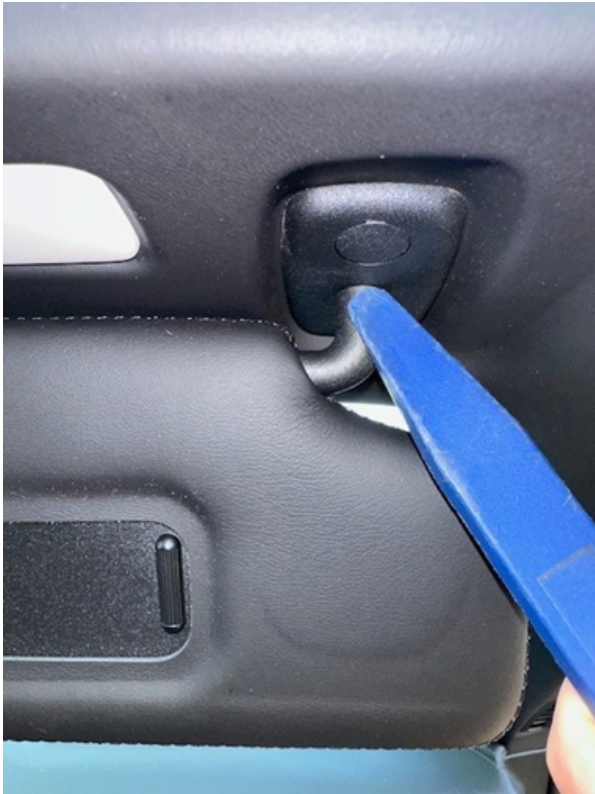
1. Unfold the passenger sun visor and check whether the shaft is fully seated.

Note: Photo indicates an intact sun visor.

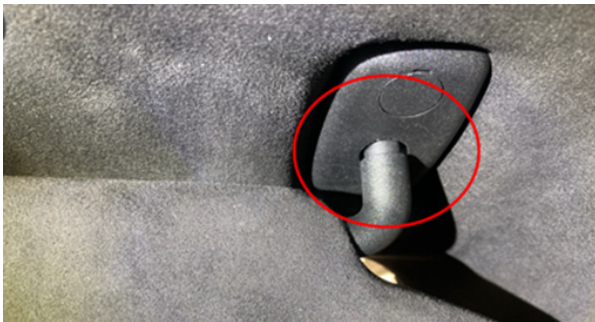
Note: Photo to the left indicates a faulty sun visor.

Note: If the sun visor is in the condition shown with part of the narrower shaft visible, the sun visor will need to be replaced following the repair instructions listed in ISTA/AIR 51 16 080.

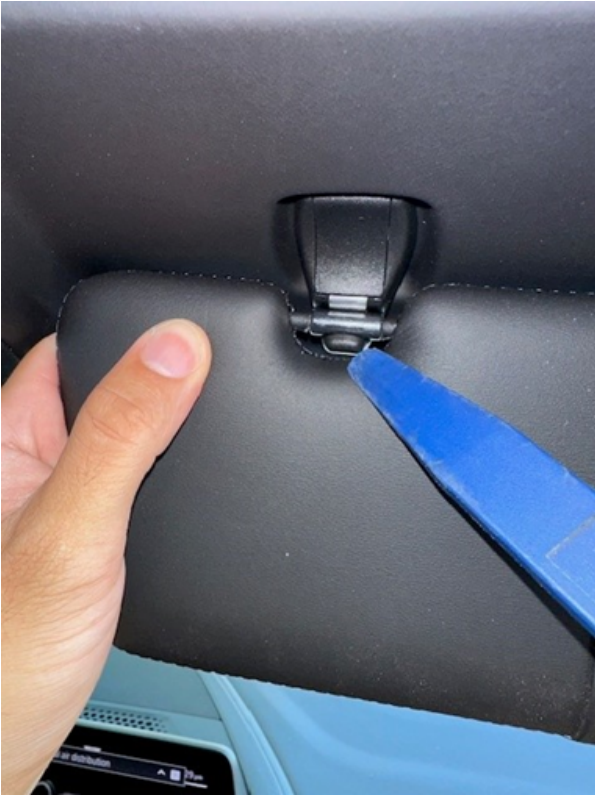
2. Remove the passenger sun visor from the end support.

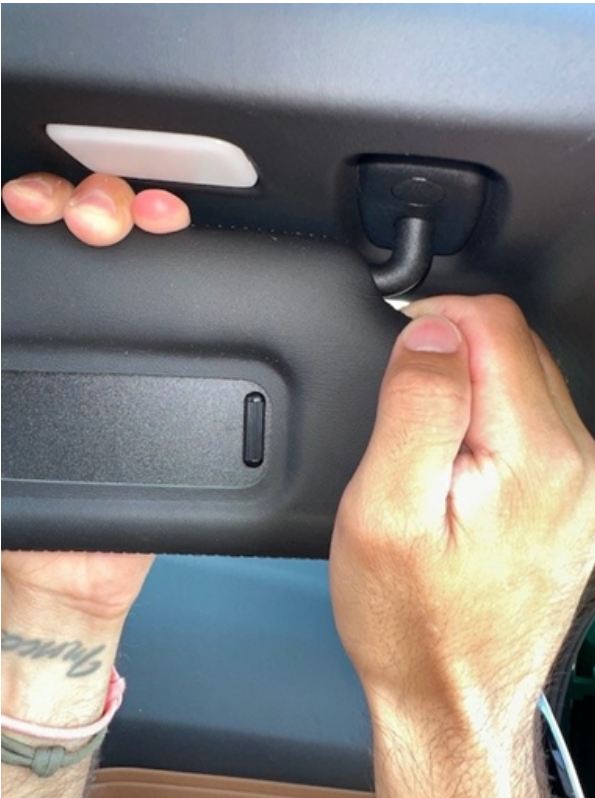
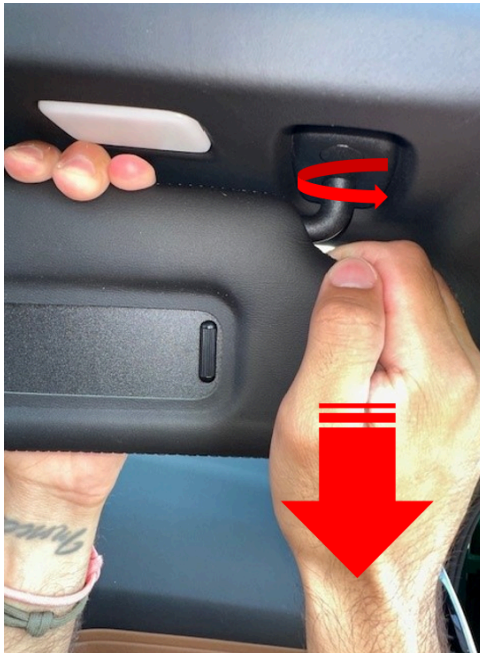
3. Grasp the sun visor with both hands as shown in the photo.

4. Pull the sun visor down with force and combine this with a swivel motion to the right and left.

Note: If the sun visor slips out of the socket, it must be replaced following repair instructions listed in ISTA/AIR 51 16 080.
