**SIB 51 20 22**

**CRACKING SOUND IN THE HEADLINER AREA**

This Service Information Bulletin (Revision 3) replaces SI B51 20 22 dated March 2023.

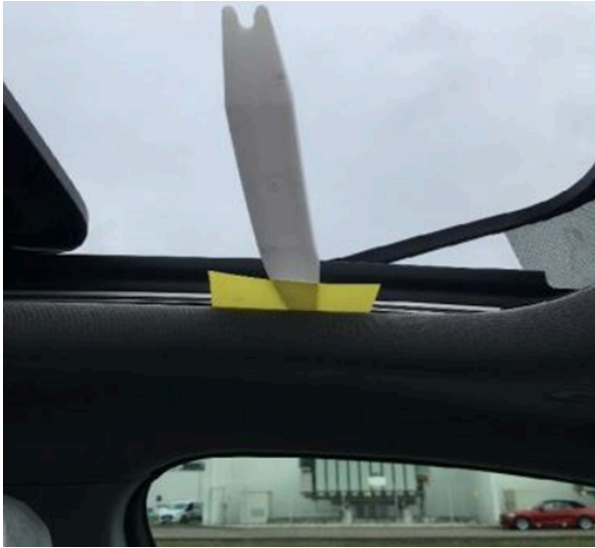
**Cause 1:**

1. The metal frame of the panorama roof cutout on the headliner is contacting the panorama roof.
2. Movement of the headliner holding clips.
3. The metal frame of the panorama roof cutout separates from the headliner.

1. Using a clip lifter, pry open the contact area to increase the gap to eliminate the contact. Make sure that the metal frame is not deformed in this visible area. If it is deformed, replacement is necessary (Reference the Cause 3 replacement repair instruction)
