SIB 61 01 24

2024-07-10

RATTLING NOISE ORIGINATING FROM WINDSHIELD WASHER FLUID RESERVOIR

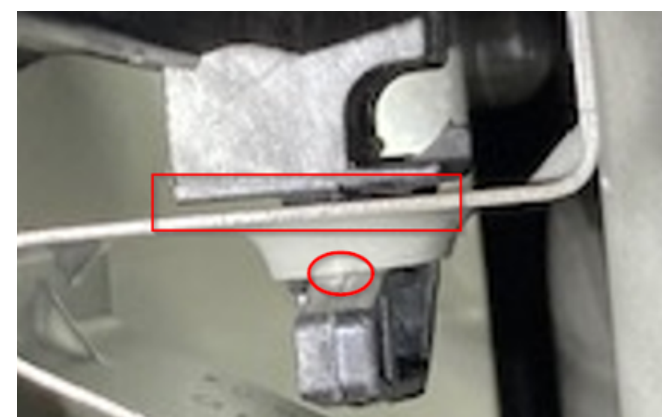
The washer fluid reservoir mounting hook has too much play, which allows the reservoir to vibrate and cause a noise.

1. Inspect the washer fluid reservoir for play or looseness, check the mounting points or areas where contact may occur.
2. Confirm the source of the noise is the washer fluid reservoir.

3. If the noise is determined to originate from the reservoir, replace it with the improved part listed below. Follow the repair instructions **“Replacing the washer fluid reservoir for the washer system 61 71 065 | REP-REP-P-6171065-G60/G70 - V.1”**.
