# Service Bulletin

Bulletin No.: 24-NA-124

**Subject: Malfunction Indicator Lamp Illuminated, Stall or No Start with DTC P2534, U3023, P0700, P129D, P10DB (w/ L5P Diesel), P103B, P17E0**

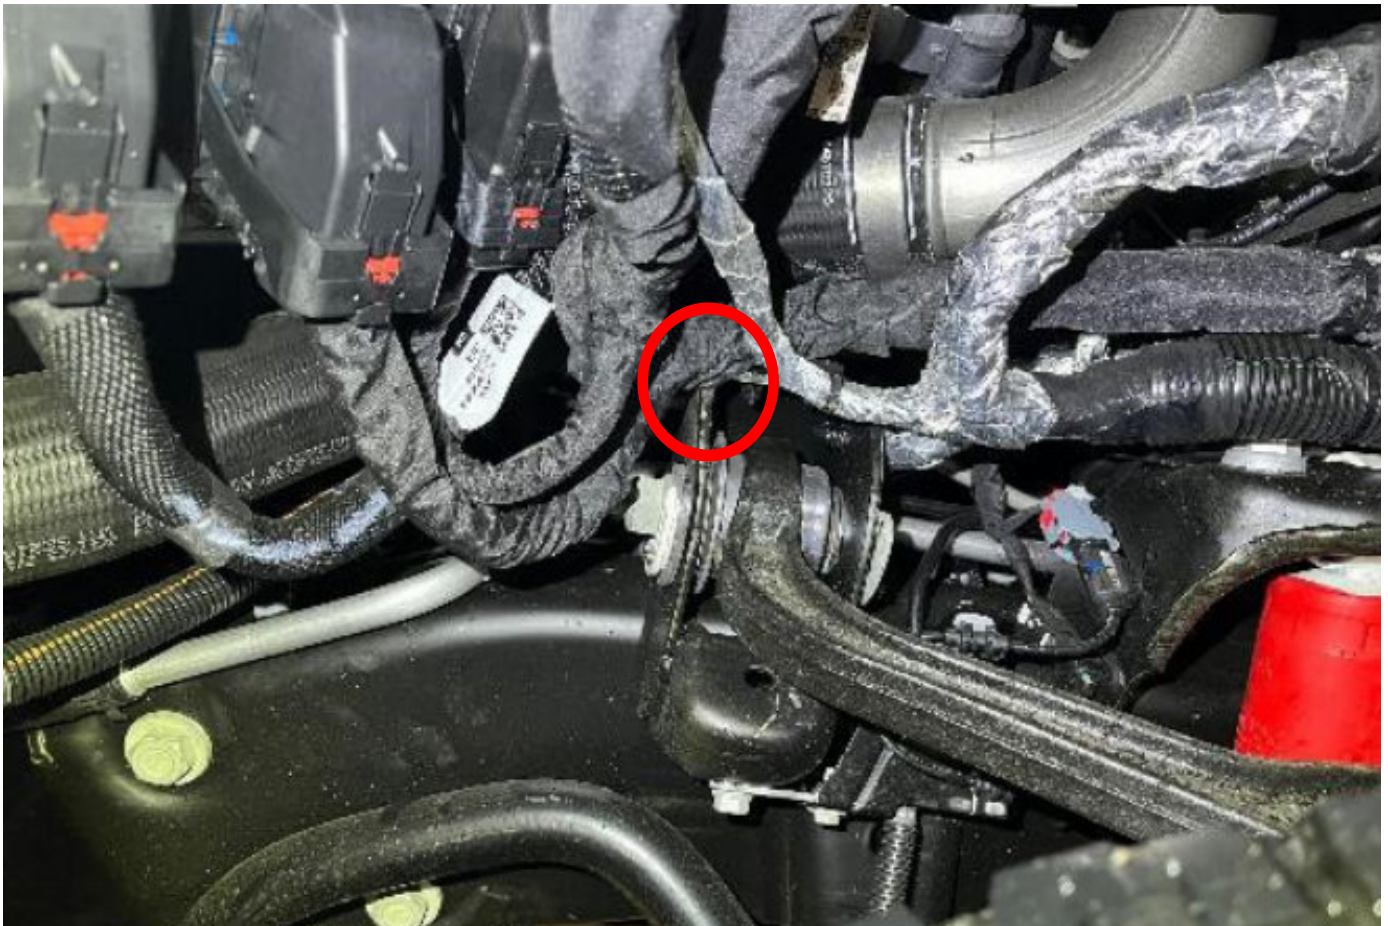
6683064

1. Lift and support the vehicle, refer to *Lifting and Jacking the Vehicle*.
2. Remove the driver-side front wheel and the wheel well liner.

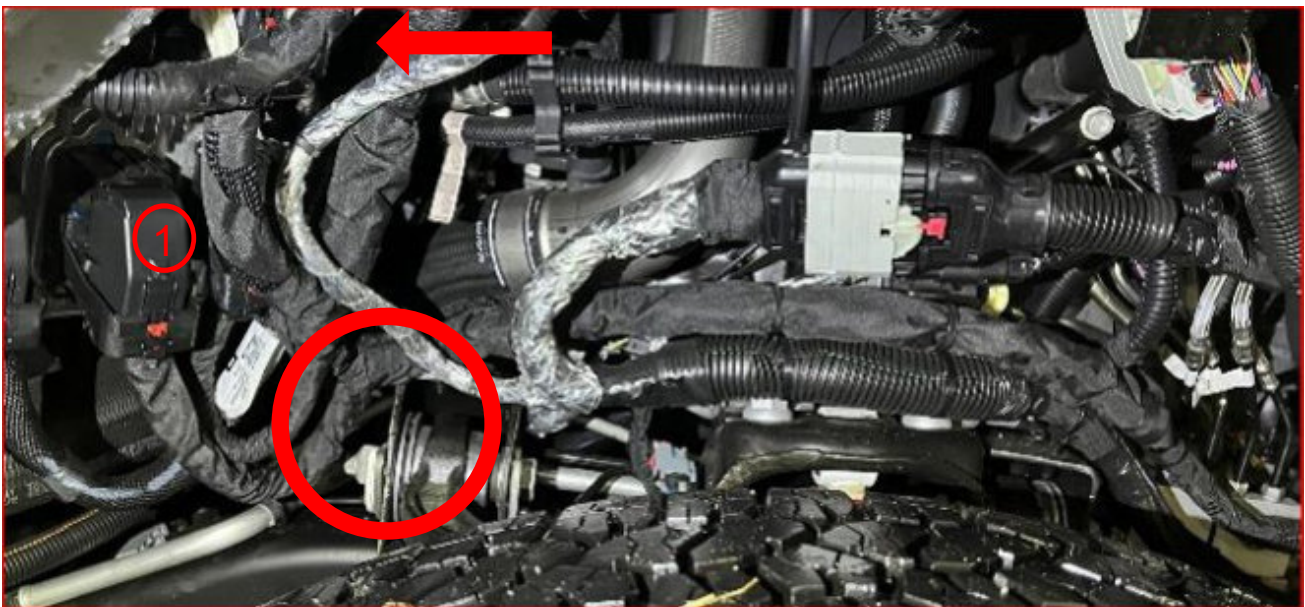
6683060

3. Inspect the engine wiring harness around the upper control arm bracket.

The arrow is pointing the front of the vehicle, the ECM is located at (1), and the wiring harness is circled.
