SIB 33 01 24

SERVICE SOLUTION: Chassis Calibration Failure

2024-07-11

Model	Type Code	Model Description
KA1	0M23	R 1300 GS

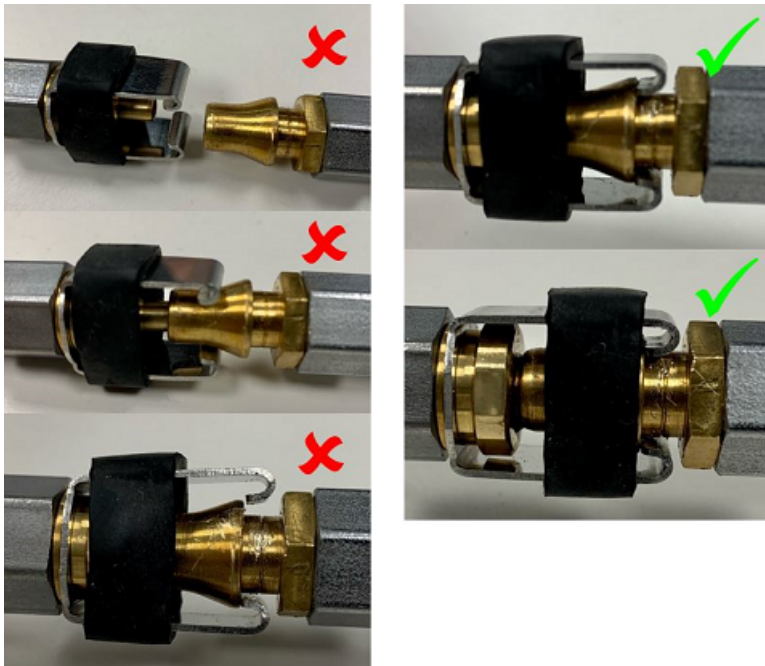
- If the chassis does not move into the high and low positions or the chassis remains in the high position,
 - Visually check system for leaks.
 - carry out a visual inspection of the snap fasteners of the hydraulic lines. Snap fasteners with retaining clips that are open due to bending can come loose during calibration. If you notice a loosened snap fastener, bend the retaining clips slightly together, connect the snap fastener correctly and slide the rubber retainer onto the clips.

- Delete the fault memory and calibrate the complete hydraulics again. Repeat one more time if necessary.

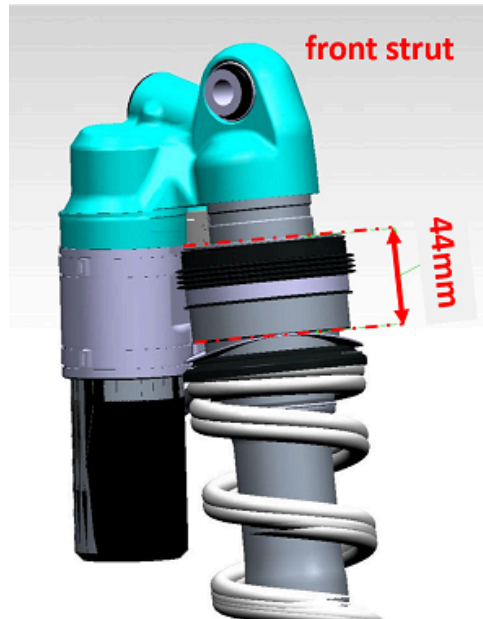
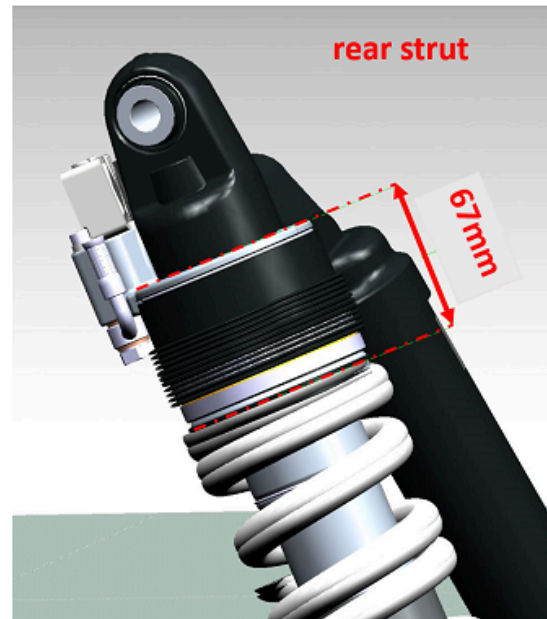
Note: Before replacing the hydraulic suspension pump, make sure that the chassis is in the low position. If the chassis is not in the low position, the suspension struts that are not in the low position must be replaced as well.

Before replacing the hydraulic pump, carry out the “Hydraulic suspension pump actuation” test module in ISTA and then the “lower chassis” test module. Please ensure that the chassis is completely lowered. If in doubt, repeat the “Lower Chassis” procedure again and press the chassis downwards as well.
