SIB 61 06 24

SERVICE SOLUTION: Drive Battery Does Not Respond

2024-07-23

Model	Model Description	Model Code
K06	CE-02	0C73

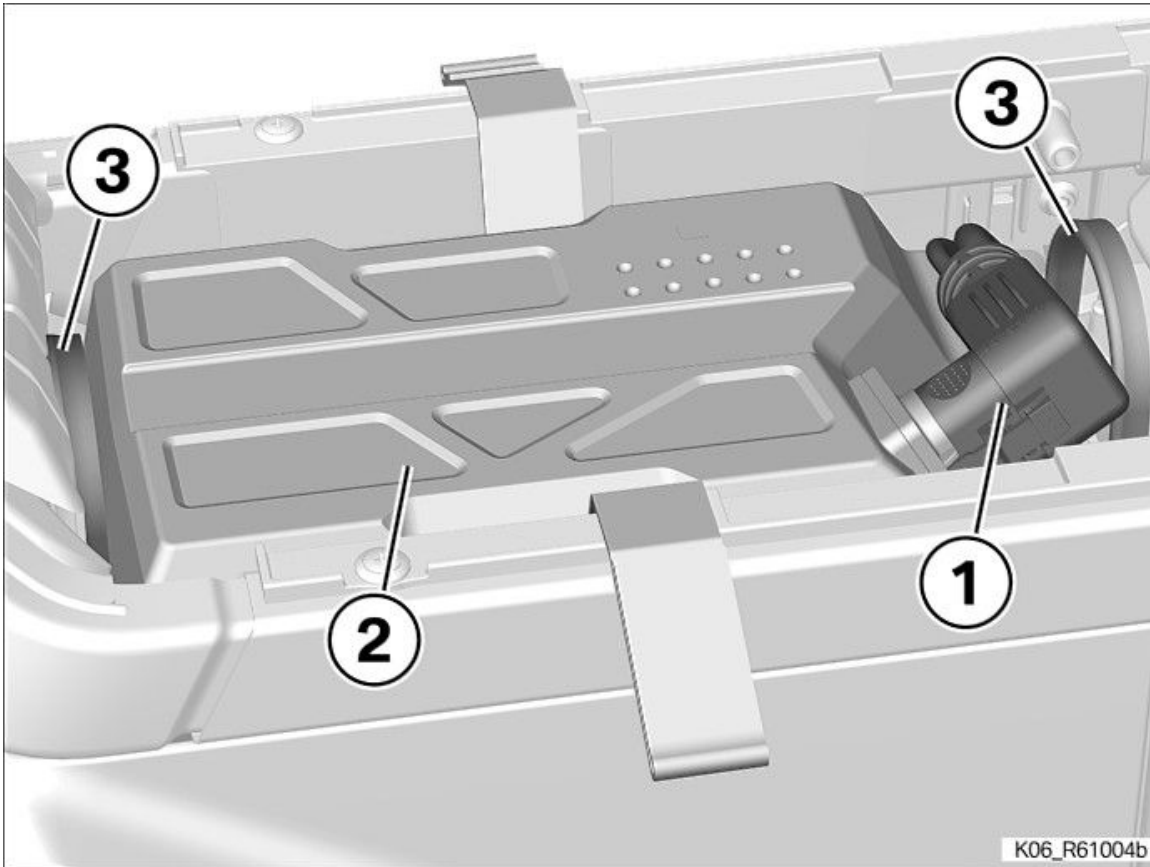
A drive battery is not recognized in the vehicle and does not respond when the charging status display key is pressed.

This is because the state of charge of the battery drops to a low voltage, the battery is put into a deep sleep mode to protect itself.

The Drive battery must be charged directly with a BMW Approved battery charger.

- Remove the seat.
- Disconnect the connector (1) for the drive battery (2) and hang to the side.
- Attach the charger directly to the drive battery at connector (1) and charge.

NOTE: If the drive battery is in deep sleep mode and connected to the battery charger, it can take several minutes for the charging status display to indicate the charging process or respond to the key being pressed.
