Service Bulletin

Bulletin No.: 20-NA-203

Subject: Information on Manual Regeneration Displayed on Drivers Information Center (DIC)

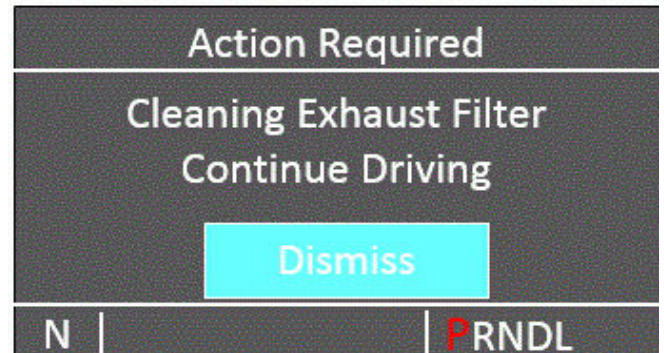
5654544

At approximately 90% soot load in the DPF, one of the messages in the graphic above will be displayed on the DIC.

These messages indicate that Manual Regeneration is available. No action is required; however, the operator may choose to perform a manual regeneration. See performing a manual regeneration below. If the message is dismissed and the vehicle has not performed a regeneration, this message will appear again on the next key on cycle.

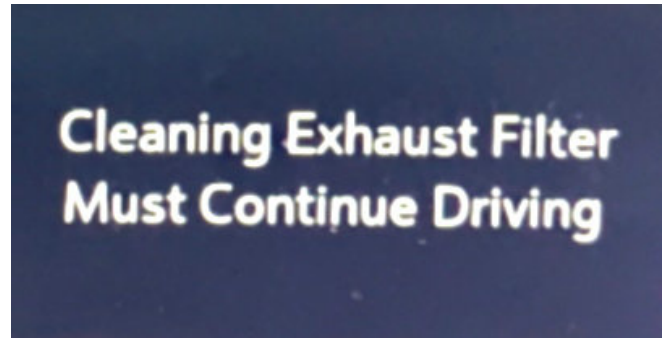
If the vehicle is shifted to park, one of the messages in the graphic above will appear.

These messages indicate that Manual Regeneration is available.

⇒ Refer to *Performing a Manual Regeneration* below.

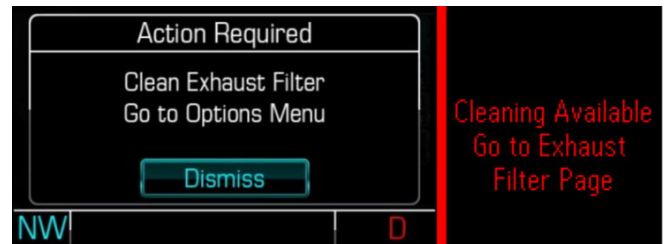
5654593

If the vehicle is being driven and the message in the graphic above is displayed, the operator may choose to stop the vehicle to perform a manual regeneration.

After making sure all the safety conditions have been met, press the trip odometer reset stem or the CheckMark on the steering wheel control for at least one second to select Start on the DIC. The DIC will display in the graphic above.

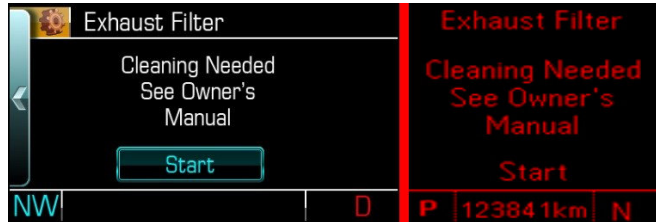
5654712

When shifting to park, scroll through the DIC pages to find the Exhaust Cleaning menu. Depending on whether the vehicle has a base or up level cluster, it may be under the Settings menu. The DIC will display a reference to refer to the Owners Manual as shown in the graphic above.

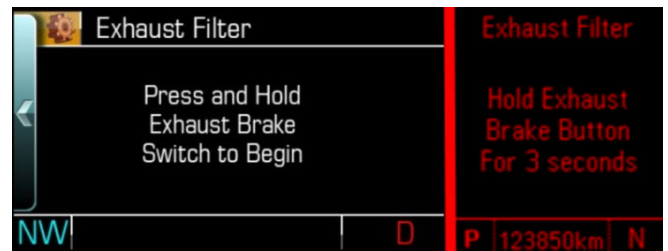
5654697

If all requirements for the manual regeneration are met, the DIC will display to Press and Hold Exhaust Brake Switch to Begin as shown in the graphic above.

Hold the exhaust brake switch on the center stack below the climate controls for more than three seconds, and then release it, to begin the regeneration process.

If the EXHAUST BRAKE ON message displays, then the switch was released too soon. Press it again to turn off the exhaust brake, then try again when the DIC message prompts.
