Yellow "Coolant" Message In Instrument Cluster

Topic number	LI20.00-P-073432
Version	3
Function group	20.00 - General
Date	7/26/24
Validity	Model series 167 with M177LS2 48 V
Reason for change	typo

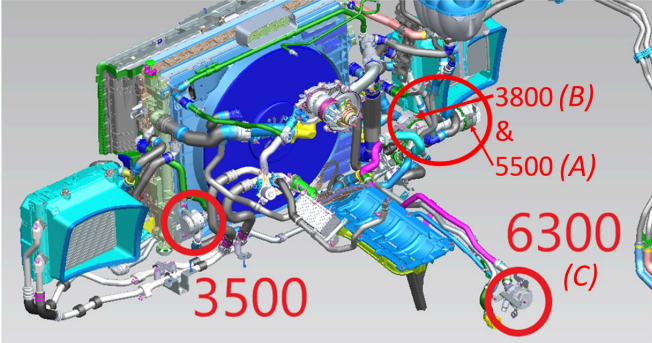
Figure 1; positions A, B and C

The fault code affects the 15W pump at the rear right of the vehicle. It is located on the side of the transmission (Fig. 1, position C).

This fault code is set because there is air in the system, so it performs an emergency dry run function.

Check the installation position of the pumps at the front right of the low-temperature circuit (Fig. 1) :

Outer: A 000 500 5500 (Fig. 1, position A)

Inner: A 000 500 3800 (Fig. 1; position B)

To start with, the pumps at front right are actuated at approx. 30%, then 50% and finally at 100%. At 100% actuation, the valve of the coolant circulating the pump at the side of the transmission is opened (Fig. 1; position C).

- The pumps at front right (Fig. 1, position A and B) always run together. These pumps must NEVER be operated separately of each other for actuation or for test purposes.
- The pump at the rear of the transmission must run permanently after being actuated. If the pump only briefly starts-up and then stops again, it is in a emergency dry run mode because there is too much air in the system. Please repeat the venting routine. If the rear pump at the side of the transmission remains in the emergency dry run mode, STOP and create a PTSS case, add the previously discovered findings to it and escalate it.
- If venting is successful, very little coolant flow noise will be present. It may be necessary to perform the venting routine several times. If after 3 venting attempts the system still has air in it, STOP create a PTSS case, add the previously discovered findings to it and escalate it.

Order new pump(s) (where the item numbers differ from the specified part number)

Outer: A 000 500 5500 (Fig. 1, position A)

Inner: A 000 500 3800 (Fig. 1; position B)
