GROUP	MODEL
Subsequent Repair Action	2020-2024MY Telluride (ON)
NUMBER	DATE
SC301Y	July 2024

Subject: **WHEEL SPEED SENSOR REPLACEMENT (SC301Y)**

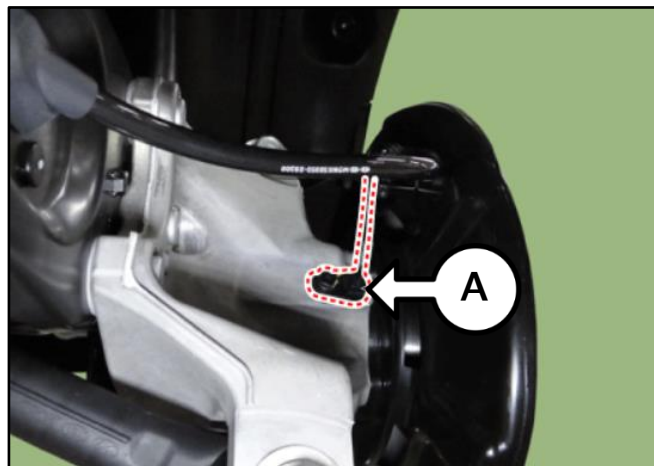
1. Confirm ABS warning lamp is illuminated and any of the DTCs listed below are stored after the WSS Software Upgrade has been performed per SC301.

- If ABS warning lamp is illuminated and any of the DTCs listed below ARE stored, then replace both rear wheel speed sensors (A) by referring to “Brake System → ESC (Electronic Stability Control) → Rear Wheel Speed Sensor → Repair procedures” in the applicable Shop Manual on KGIS.
