GROUP	MODEL
CHA	2019-2024MY Multiple Models
NUMBER	DATE
121 (Rev 1, 7/26/2024)	January 2024

TECHNICAL SERVICE BULLETIN

SUBJECT: **FRONT STRUT BEARING & SPRING PAD REPLACEMENT**

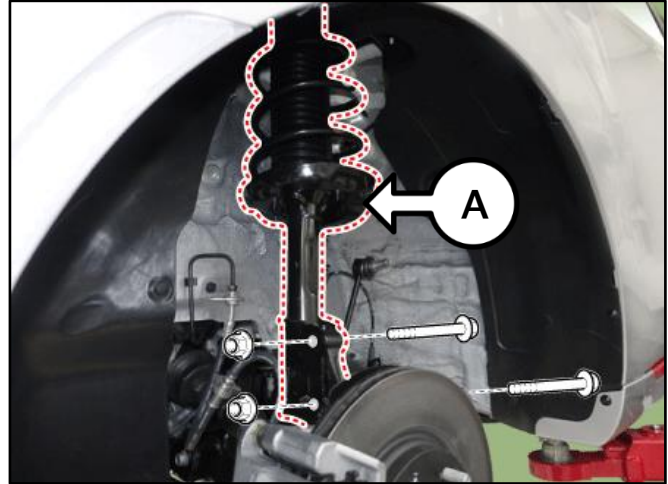
1. Remove the front strut assembly (A), both left and right side, by referring to "Suspension System → Front Suspension System → Front Strut Assembly/Front Strut Complete → Repair Procedures (Removal and Installation)" in the shop manual on KGIS.

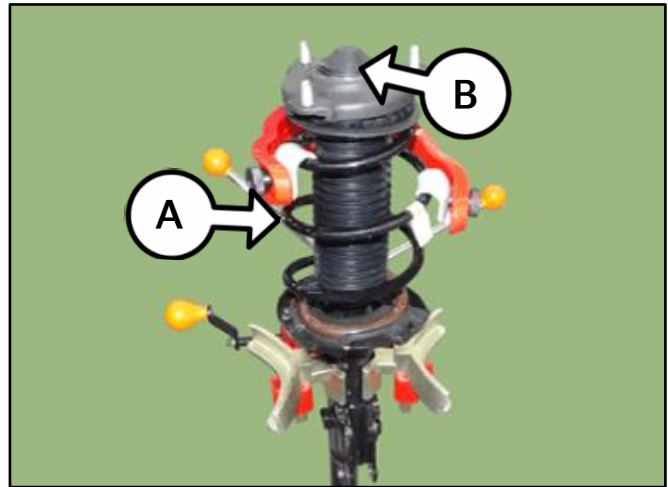
2. Disassemble one of the front strut assemblies (A) by referring to "Suspension System → Front Suspension System → Front Strut Complete → Repair Procedures (Disassembly)" in the shop manual on KGIS.

Note: SST 09546 3X100 is required to loosen the self locking nut (B). DO NOT reuse the removed locking nut (discard after removal).

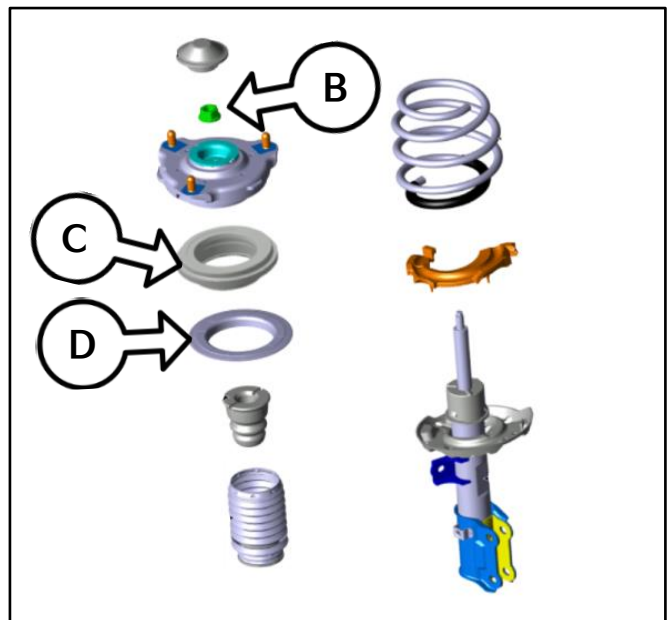
3. Replace the strut bearing (C) and the spring pad (D) with the new parts.

Note: INSTALL a 'new' locking nut (B).

Tightening torque for locking nut (B):
39.8 - 54.2 lb.ft (53.9 - 73.5 N.m)
