# Service Bulletin

Bulletin No.: 24-NA-021

**Subject: Information on Malfunction Indicator Lamp (MIL) Illuminated with Any Combination of DTCs P0521, P06DD and/or P06DE Setting**

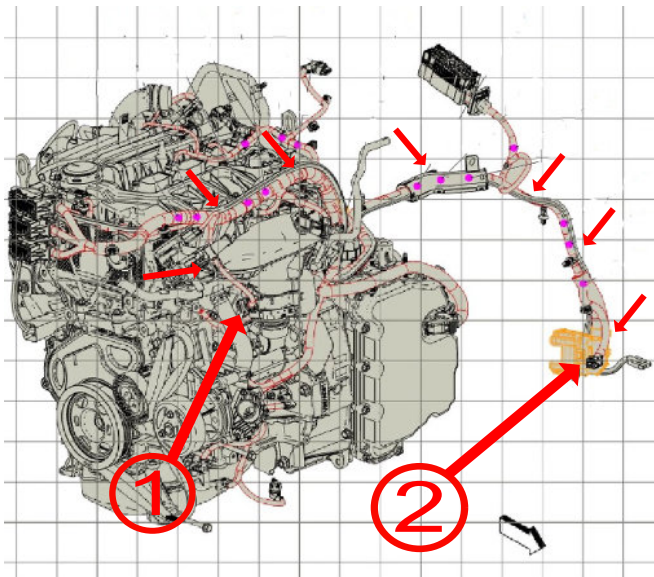
6374708

- Control terminal 2/B & Ignition terminal 1/A of the engine oil pressure control solenoid valve.
3. If within range, inspect the solenoid valve for signs of debris.
    - ⇒ If no debris are found and the concern is not isolated to the engine oil pressure control solenoid valve, refer to *Engine Oil Pressure Sensor Replacement* in SI to **inspect** the engine oil pressure sensor.
  4. Disconnect the engine oil pressure sensor and test for less than 10 Ω between the low reference circuit 580 terminal 2 and ECM connector X1-terminal 23.

- If the resistance is within range, tap and manipulate the engine wiring harness between the oil pressure sensor (1) and X125 (2), while monitoring for a change in the resistance reading.
- If the concern is not isolated to the engine wiring harness, reinstall all components and perform the Engine Oil Pump Screening Test.

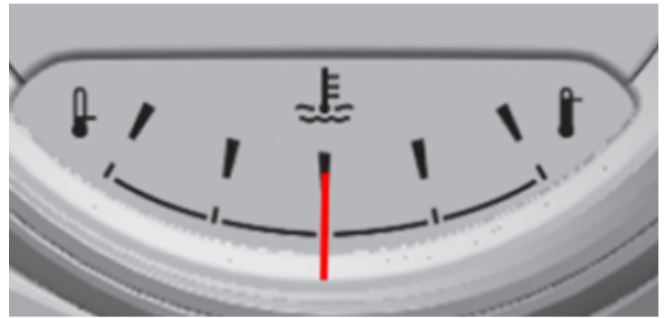
6379891

1. Park the vehicle in a safe location. Put the transmission in park and apply the parking brake.
2. Connect the MDI or MDI2 and start GDS.
  - ⇒ Clear all codes in the vehicle, and double check that there are no codes in the ECM before starting the procedure.
3. Module Diagnostics => [K20] Engine Control Module => Data Display => Engine Mechanical Data

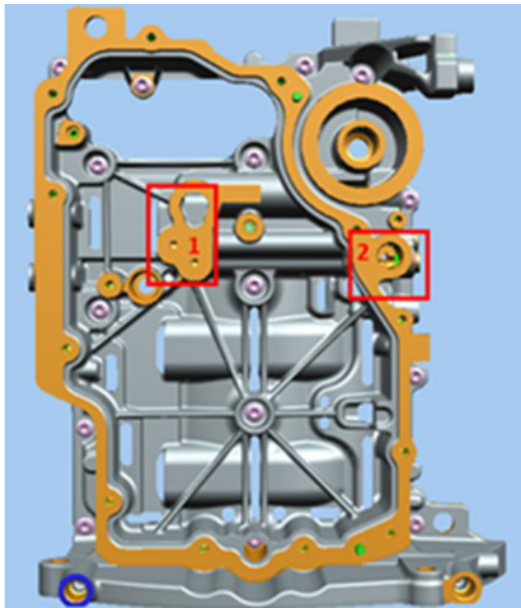
6379894

**Caution:** If oil pump replacement is needed, ensure the three oil pump oil holes (Area 1) and OCV mounting hole (Area 2) are free of debris BEFORE installing the oil pump and OCV. If debris is found, remove with a lint-free cloth or brush that will not scratch the surface.
