Service Bulletin

Bulletin No.: 24-NA-129

Subject: Water Leak from Around Windshield Area

Brand:	Model:	Model Year:		VIN:		Engine:	Transmission:
		from	to	from	to		
BrightDrop	Zevo 600	2023	2024	-	-	All	All

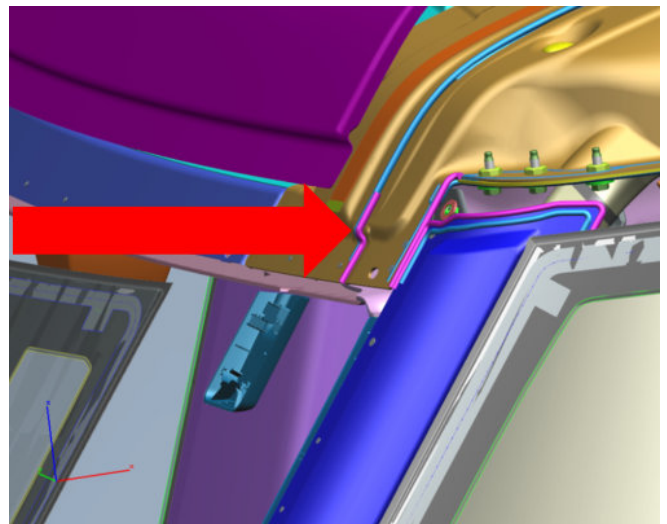
6688562

Note: Source of water leak found at the “rat hole” between finished roof panel and roof cap panel.

1. Remove both Left and Right roof panel joint front finish moldings. Refer to *Roof Panel Joint Front Finish Molding Replacement* in SI.

2. Remove headliner to improve visibility for water leak test. Refer to *Headlining Trim Panel Replacement – (Left and Right) Side* in SI.

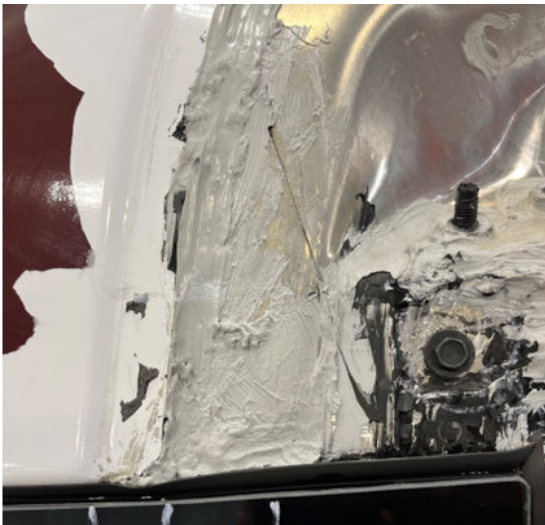
6688566

Illustration above shows un-prepped surface with old sealer present.

3. Air bubble test using soapy solution and air gun to confirm the rat hole is the cause of the leak.
4. Clean and prep both sides of the vehicle. Wipe aluminum surfaces with Kent Acrysol, P20005, or equivalent, to remove any residual sealer or urethane. Wipe down all aluminum surfaces with 70% Isopropyl Alcohol.

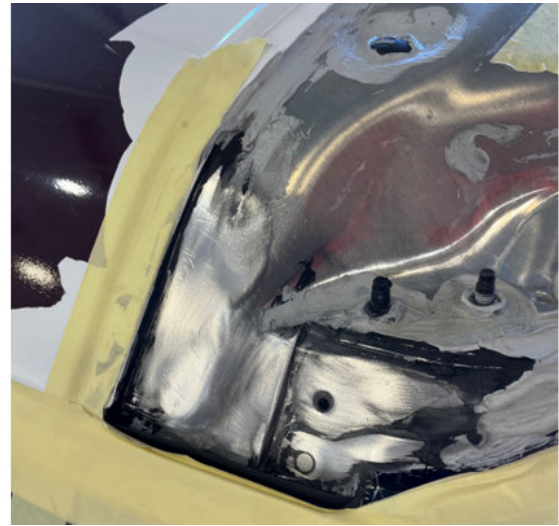
6688568

Illustration above shows prepped surface – all sealer removed.
