McLaren Speedtail - Clam and Harness Rework

Bulletin type:	Service Campaign
Reference number:	N/A
Campaign reference:	SCB 23 M 007
Attention:	Retailer Aftersales Managers, Retailer Service Managers, Retailer Service Advisors, Retailer Technicians, Retailer Parts Managers
Affected vehicles:	McLaren Speedtail
Situation:	Rear body clam and harness rework
Procedure:	Action affected vehicles on first opportunity (immediately if already on site or during next Retailer visit if not already on site). Please refer to the information outlined in this document to complete the required work
Date:	25 July 2024

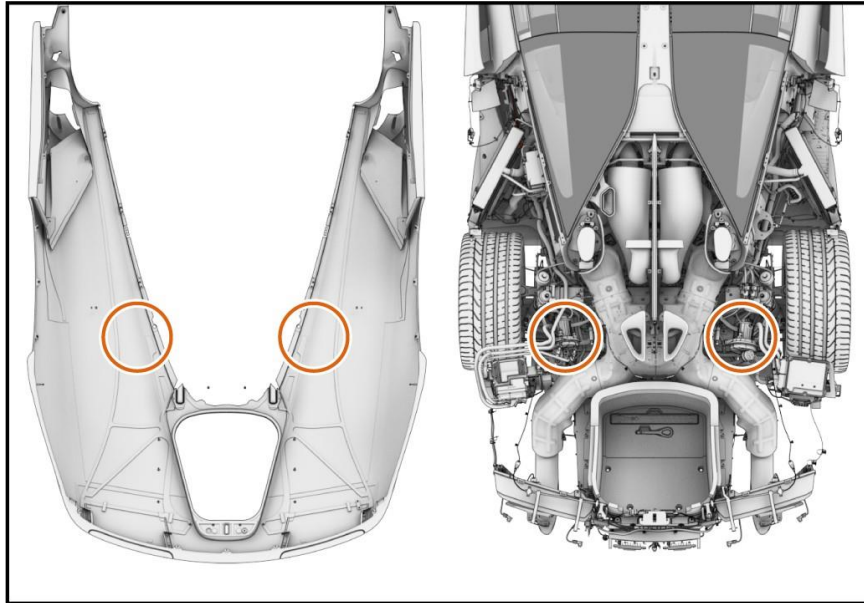
Image 1 Rework Area

Through continuous product quality monitoring, McLaren Automotive has identified an opportunity to enhance the routing of the body harness in the engine bay area under the rear clam. The rework activity outlined below will eliminate the possibility for certain sections of the rear harness to clash with the underside of the rear body clam.
