# McLaren Artura Interior Rear View

## Mirror Rattle

**Topic:** Rattle from interior rear view mirror shroud when driving

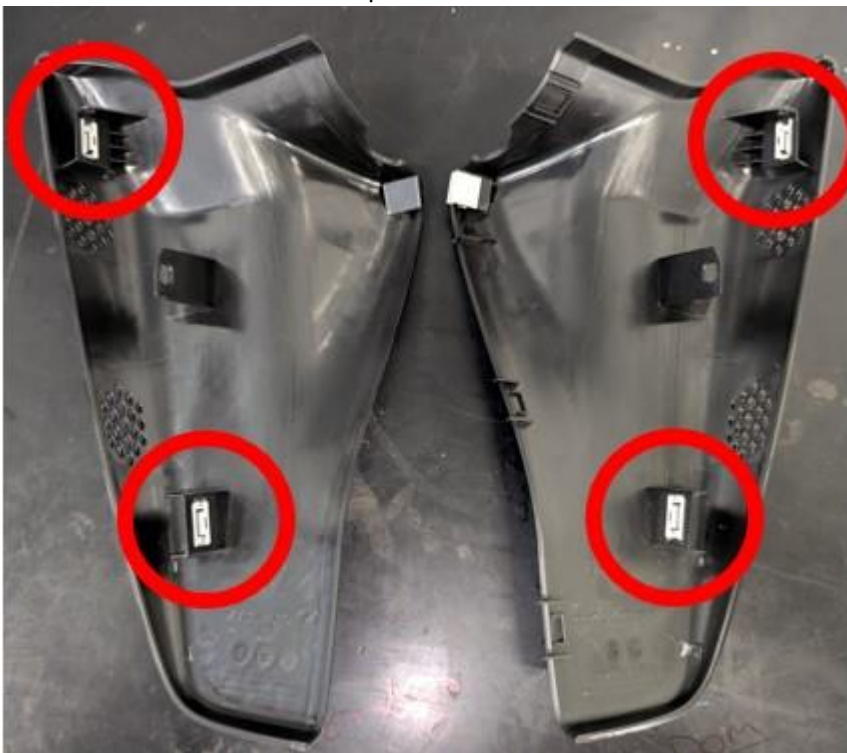
In the event that a rattle is audible from within the rear view mirror shroud, please complete the following measure as a first action.

- Remove the rear view mirror shroud trim complete
- Locate the 4 x metal clips circled below

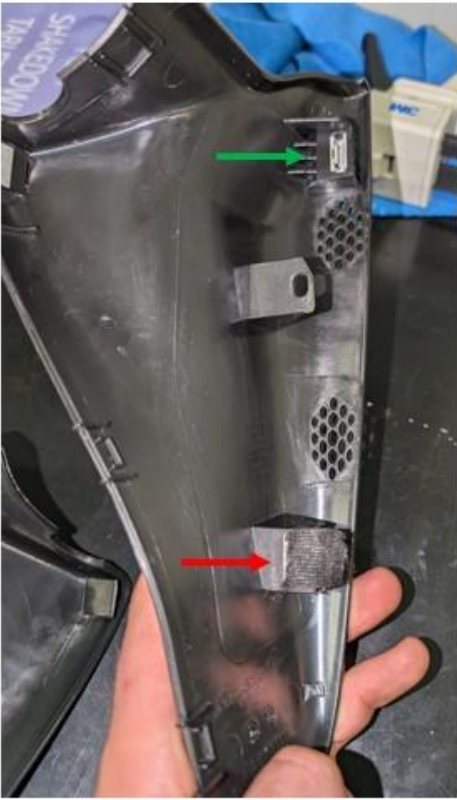
Care Point: Do not cover the slotted area on the back of the clip (OK/NOK condition shown below)

OK - tape does not cover slot

NOK - tape covers slot
