# AIRSTREAM®

## Airstream Atlas E1 & Interstate 24 E1 & 19 E1 Touring Coach Technical Service Bulletin #200 – Airstream and Volta E1 Package Updates

**Date:** 7/17/2024

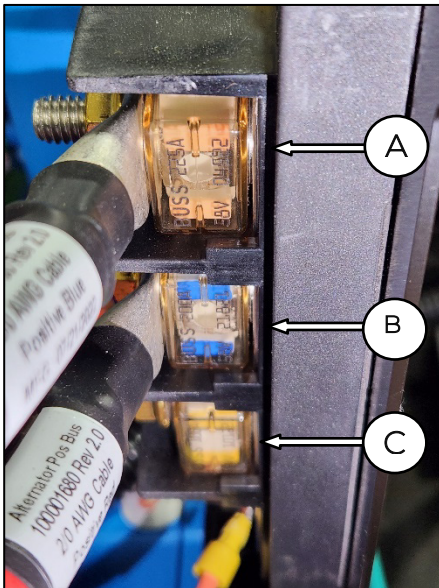
- A. 250A Fuse for the Volta FLEX pack.
- B. 200A Fuse for the Alternator
- C. 100A Fuse for the Inverter being replaced with 175A fuse.

Refer to the following diagrams for internal fuse location and installation best practices. The fuse being replaced is fuse C below, with a 175A block fuse.
