# SS 3152-FTL New Cascadia Lytx SF500 intermittent video feed issues

This Service Solution applies to New Cascadia vehicles built with data code (3ZS-015- LYTX SF500 DRIVECAM SYSTEM, FACTORY/CTS INSTALLED).

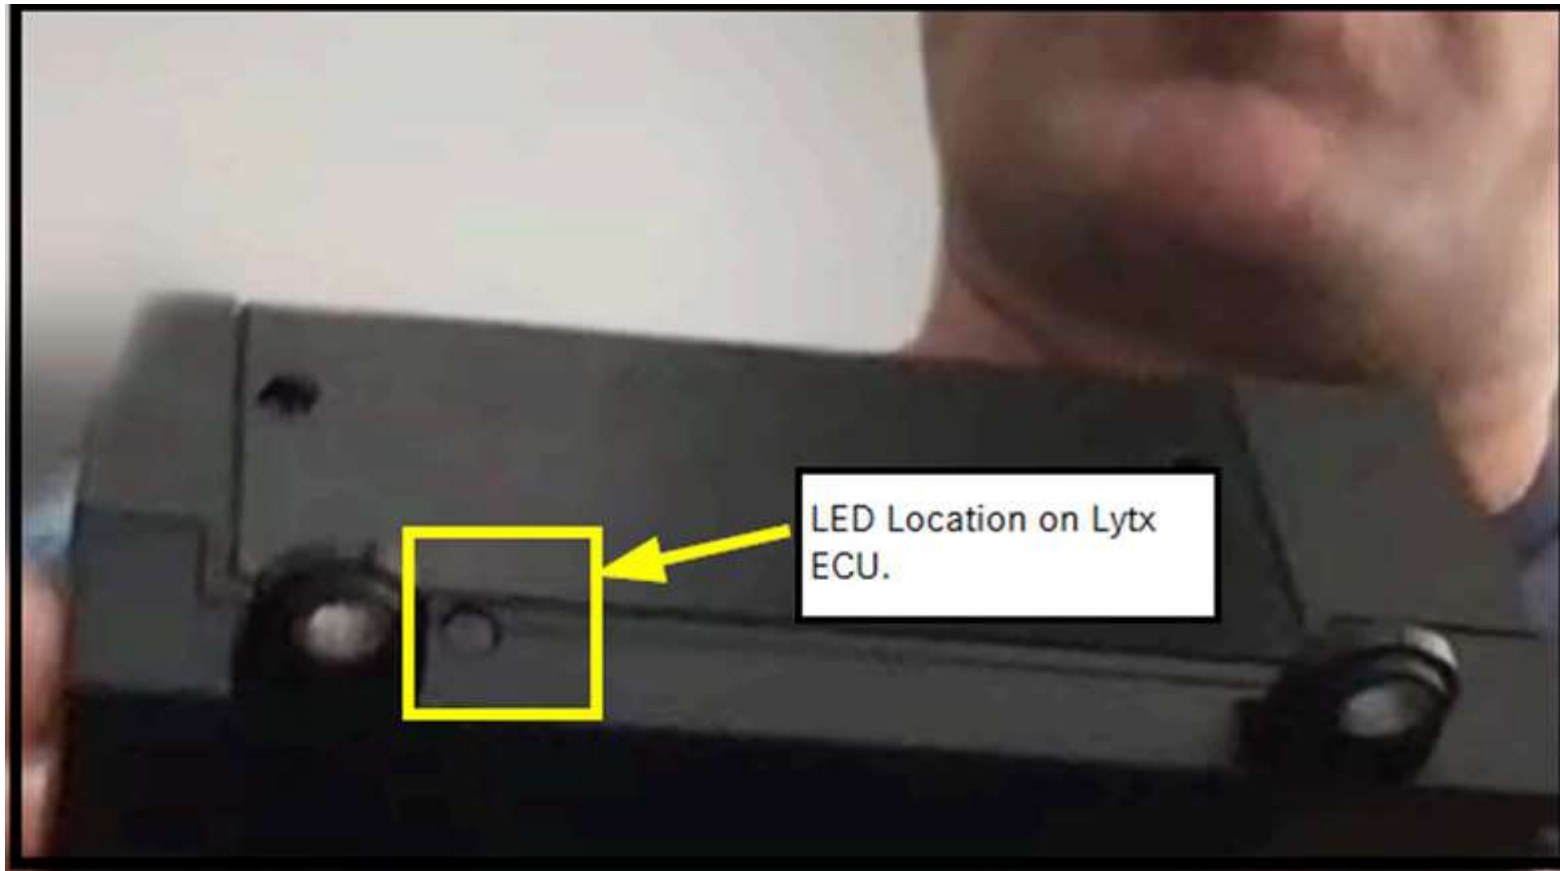
**Figure 1**

Lytx pushed out an "Over The Air" update to all of the SF500 ECUs that completed by July 12th 2024 changing the function of the LED located on the Lytx ECU. The location of the LED on the Lytx ECU can be seen in Figure 1. Make sure to have the ignition switch on when checking the LED, reference Figure 3 for location of Lytx ECU.

1. No LED color = no power to the ECU
2. Red = Power is connected
3. Green = If camera is connected and synced to the ECU (Green is Good)

5. Once all of the wires and cables are routed per the instructions above, turn on the ignition switch and validate that the LED on the Lytx ECU module Figure 1 is green.
6. Reinstall all panels that had been removed to correctly install the Lytx cables and wires.
