# CXA Requested Topic

# TSB-35-042-FTL

## HIGH TEMP, TRACTOR, NO AXLE TEMP SENSORS, LUBE OKAY

# Leaking Pinion Cover New Final Drive

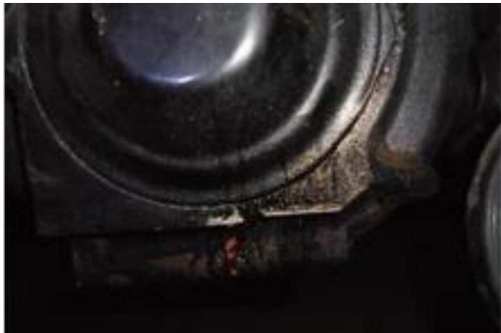
## Description

- Leaks on the New Final Drive pinion cover (forward rear axle).
- Some root causes are the Loctite sealant drying prior to cover installation, pinion cover damage prior to installation, and a pinion cover not made correctly.
- ZEUS 1956773 & FSPR 29390.

- Added inspection of pinion cover to check list in Sep-17.
- Single bead of Loctite spread up along sides in Sep-17. Goal is to achieve increased contact with OD of cover.
- Window optimization has been increased to detect damaged pinion covers in Sep-17.
- New integrated seal on the cover implemented with [PII Removed].

- TBD. Tooling is being developed to replace the cover.
