eP4 EVDM Ground Cable Terminal Broken

Field Service Campaign SF-694

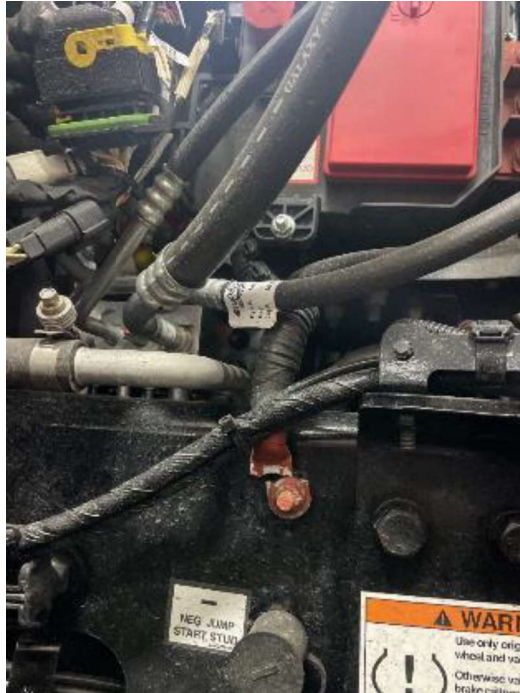
- EVDM ground cable terminal breaks at frame attachment, due to fatigue
- Ground is redundant, so may be no symptoms

- Relative motion between front box assembly and frame
 - Front box is mounted to chassis with rubber isolators
- Cable too short and has no strain relief

- Design changed from 13" to 20" cable, with lower stud location and added bracket for strain relief
 - Production Changeover: 11/20/2023
