Technical Service
Bulletin

Subject: FRONT AND REAR BRAKE NOISE	Bulletin No.: 04-003/24
	Last Issued : 07/09/2024

2013-2025 CX-5

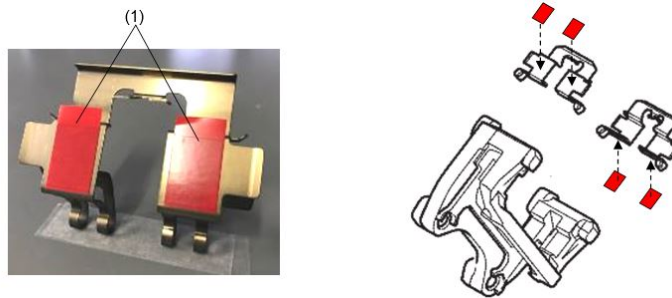
Rear Brake Noise Symptom 1: Some vehicles may exhibit a squeak noise from the rear brakes while braking lightly and occurs more frequently when driving at slow speeds. The noise is caused by poor contact between the guide plate and the mounting support. To eliminate this concern, the material of the pads has been changed to copper-free and the specification of the shims has been changed to a coated spring with tape.

- Verify if the tape is installed to both guide plates (some kits do not have the tape installed and is packaged separately).
- If the tape is not applied to the guide plates, peel off the red release film (1) and the dual adhesive tape (2) from the release paper (3) and apply the dual adhesive tape to the contact surfaces of the guide plates as shown below.

NOTE: Red adhesive tape is only supplied for the rear brakes.
