Technical Service Bulletin

Subject: SCRATCH ON SEAT BACK BAR GARNISH FROM CONTACT WITH CONVERTIBLE TOP	Bulletin No.: 09-016/24
	Last Issued : 07/18/2024

APPLICABLE MODEL(S)/VINS:
2016-2024 MX-5

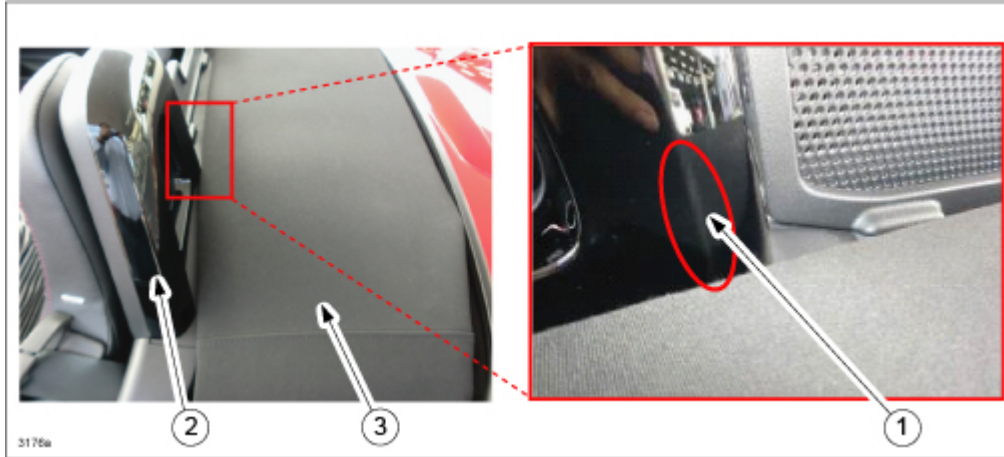
Some vehicles may exhibit scratches (1) on the rear of the seat back bar garnish (2) from contact with the convertible top (3).

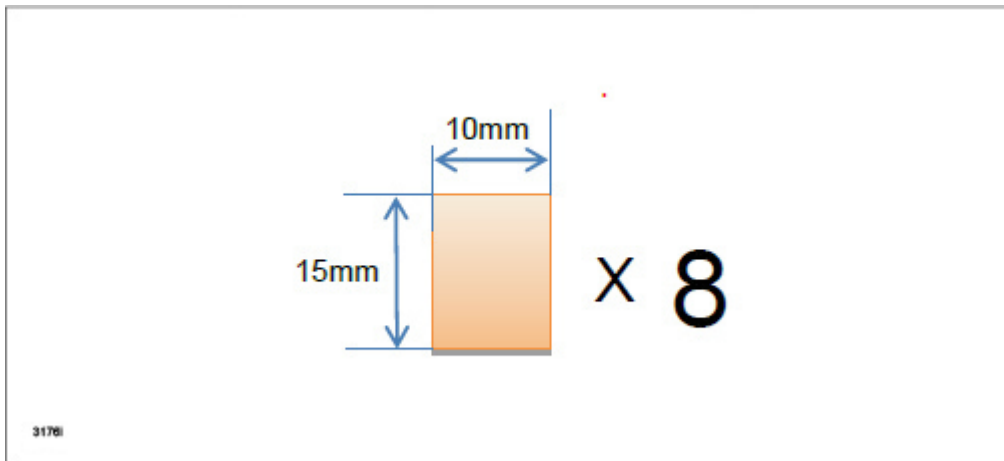
NOTE: The holes may be damaged when removing the metal fasteners of the back trim from the square holes of the seat back crossmember. A loose fit of these fasteners could cause a creak noise.

a. Select a 0.25 mm thickness fabric sheet from the "Noise Repair Kit" (TA01-76-100) and cut out 8 equal squares 15mm x 10mm.
