# Technical Service Bulletin

<b>Subject:</b>  POWER LIFTGATE MAY OPEN UNINTENTIONALLY WHILE VEHICLE IS PARKED/STOPPED	<b>Bulletin No.:</b> 09-022/24
	<b>Last Issued :</b> 07/25/2024

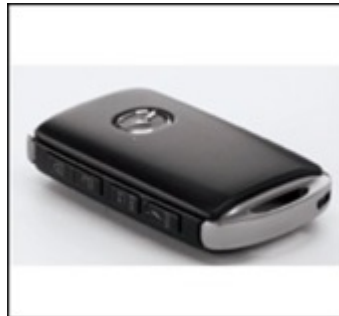
7th Generation Transmitter

Due to the shape of the 7th generation remote transmitter, the power liftgate button may be long pressed unintentionally in a pocket or a bag. To eliminate this concern, the keyless control specification has been modified. The button press time has been increased from 0.5 seconds to 1 second.

1. Verify the concern.
2. Replace the start stop unit according to the instructions on MGSS:
  - CX-5: START STOP UNIT REMOVAL/INSTALLATION
  - CX-9: START STOP UNIT REMOVAL/INSTALLATION
3. Verify the repair.

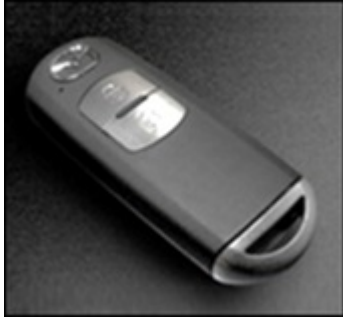
6th Generation Transmitter

**CAUTION:** Vehicles with 6th generation remote transmitter do NOT apply to this Service Information.
