Technical Service Bulletin

Subject: BATTERY DISCHARGED DUE TO SEAT VENTILATION MALFUNCTION	Bulletin No.: 09-035/24
	Last Issued : 07/17/2024

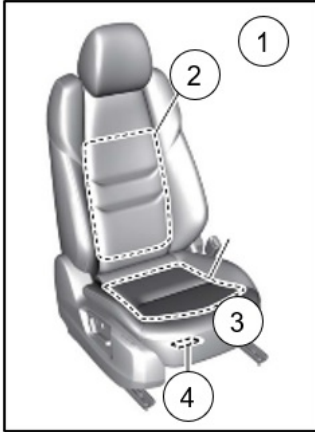
Some vehicles may experience the seat ventilation system still on after the engine has been turned off, in some cases this causes the battery to be completely discharged and not rechargeable. This is caused by a deterioration in the seat ventilation control unit. To eliminate this concern, the material for the circuit of the seat ventilation control unit has been modified.

- (1) Passenger side
- (2) Seat ventilation unit (Seat back side)
- (3) Seat ventilation unit (Seat cushion side)
- (4) Seat ventilation control unit

2. Replace the front seat warmer control unit according to the instructions on MGSS (FRONT SEAT WARMER CONTROL UNIT REMOVAL/INSTALLATION).

NOTE: The front seat ventilation control unit is integrated with the front seat warmer control unit located on the bottom of the passenger side front seat.
