# SS 766-WST Western Star X-series Lytx SF500 intermittent video feed issues

This Service Solution applies to Western Star X-series vehicles built with data code (3ZS-015- LYTX SF500 DRIVECAM SYSTEM, FACTORY/CTS INSTALLED).

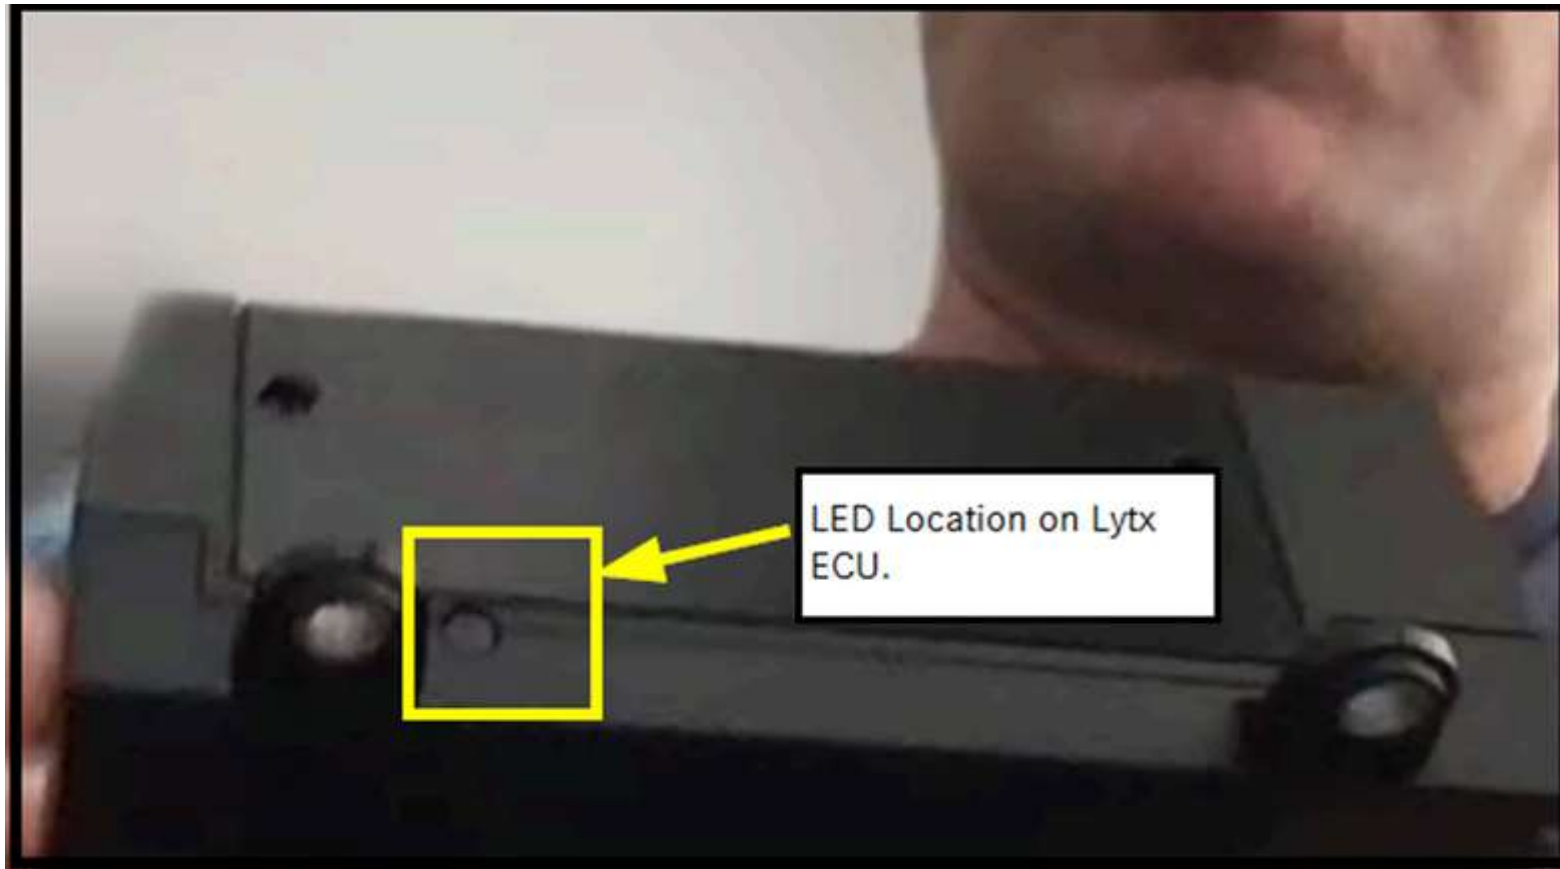
## Figure 1

Lytx pushed out an "Over The Air" update to all of the SF500 ECUs that completed by July 12th 2024 changing the function of the LED located on the Lytx ECU. The location of the LED on the Lytx ECU can be seen in Figure 1. Make sure to have the ignition switch on when checking the LED, reference Figure 3 for location of Lytx ECU.

The LED has three states.

1. No LED color = no power to the ECU
2. Red = Power is connected
3. Green = If camera is connected and synced to the ECU (Green is Good)

5. Once all of the wires and cables are routed per the instructions above, turn on the ignition switch and validate that the LED on the Lytx ECU module Figure 1 is green.
6. Reinstall all panels that had been removed to correctly install the Lytx cables and wires.
