## EGR Valve Diagnosis and Cleaning Procedure using TU-NAP 926® on 906, 907 Sprinter with OM642 Diesel Engine

Topic number	LI14.20-N-073867
Version	5
Function group	14.20 - Exhaust gas recirculation
Date	7/3/24
Validity	906, 907 Sprinter with OM642 V6 Diesel Engine
Reason for change	Update Work Instructions

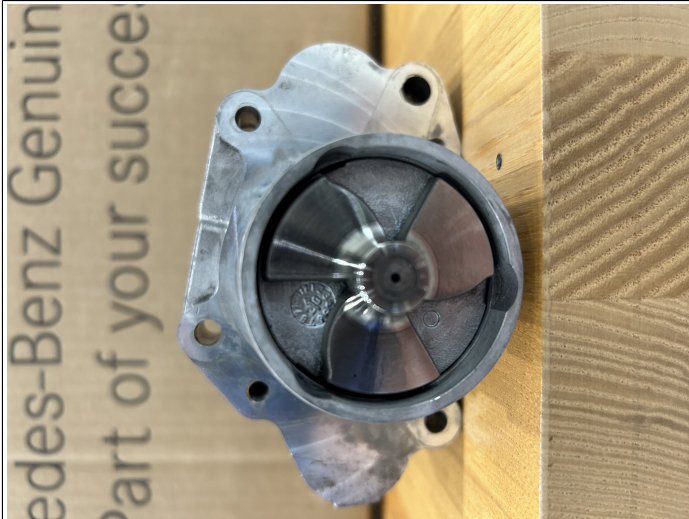
OM642 EGR After Cleaning 2.JPG

Side view of cleaned EGR Valve.

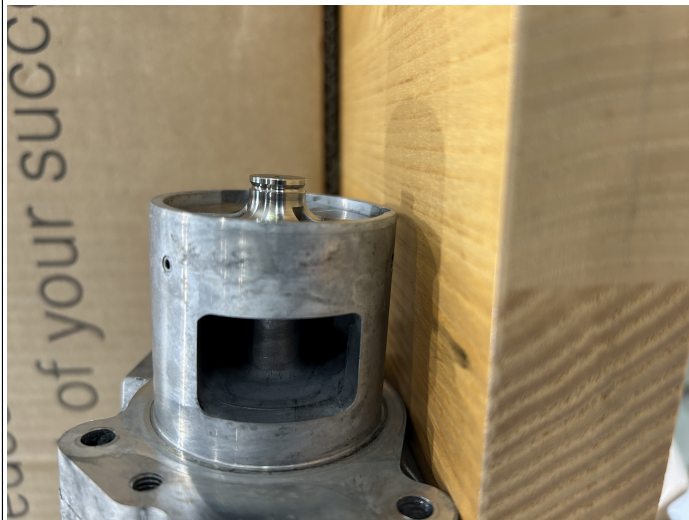
EGR Valve Cleaner Application.JPG

EGR Valve with cavity filled, and blades covered in cleaner.

2. Position EGR Valve so open cavity is facing upward. Fill cavity with cleaner, and then proceed to apply cleaner to blades from the outside. Additionally, apply cleaner to outside where additional soot is found.
