Service Alert

Subject: HOOD CANNOT BE OPENED	Service Alert No.: SA-048/24
	Last Issued : 07/25/2024

2025 CX-70

2024-2025 CX-90

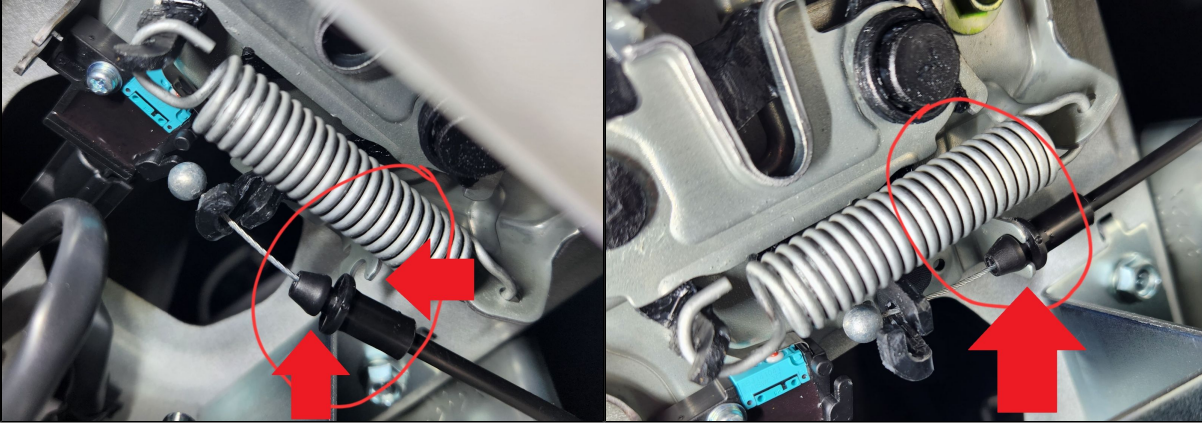
Some customers may experience an issue where the hood cannot be opened using the release cable. To open the hood for diagnosis and repairs, follow the repair procedure below.

The procedure in MGSS directs you to remove the front bumper for hood cable and latch repairs, however, you need the hood open to do that. To open the hood, you do not need to remove the bumper, and the final repair may be as simple as properly attaching the cable to the latch. (See the photos below.)

1. Pull the inner fender panel.
2. Reach up to access the hole in the core support.
3. Manually operate the lever to open the latch.
4. Repair the vehicle as needed.
