**SERVICE INFORMATION BULLETIN**

**APPLICABILITY:** All Models

**NUMBER:** 05-91-24

**SUBJECT:** Shock/Strut Leak Diagnosis

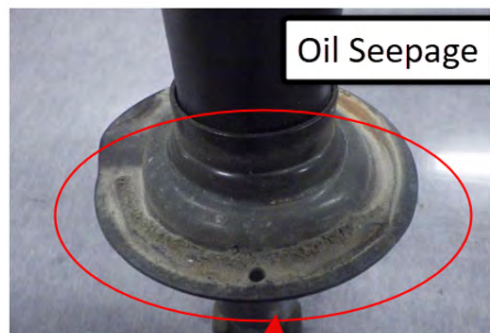
**OIL SEEPAGE:**

Oil located at the top end of the outer tube and/or oil located just above the spring seat does not indicate a leak condition requiring strut repair or replacement. These conditions are considered normal operation.

If dry dust, without any oil residue visible, is found on the top surface of the lower seat, it is considered oil seepage. This seepage is considered a normal condition and does not require replacement.

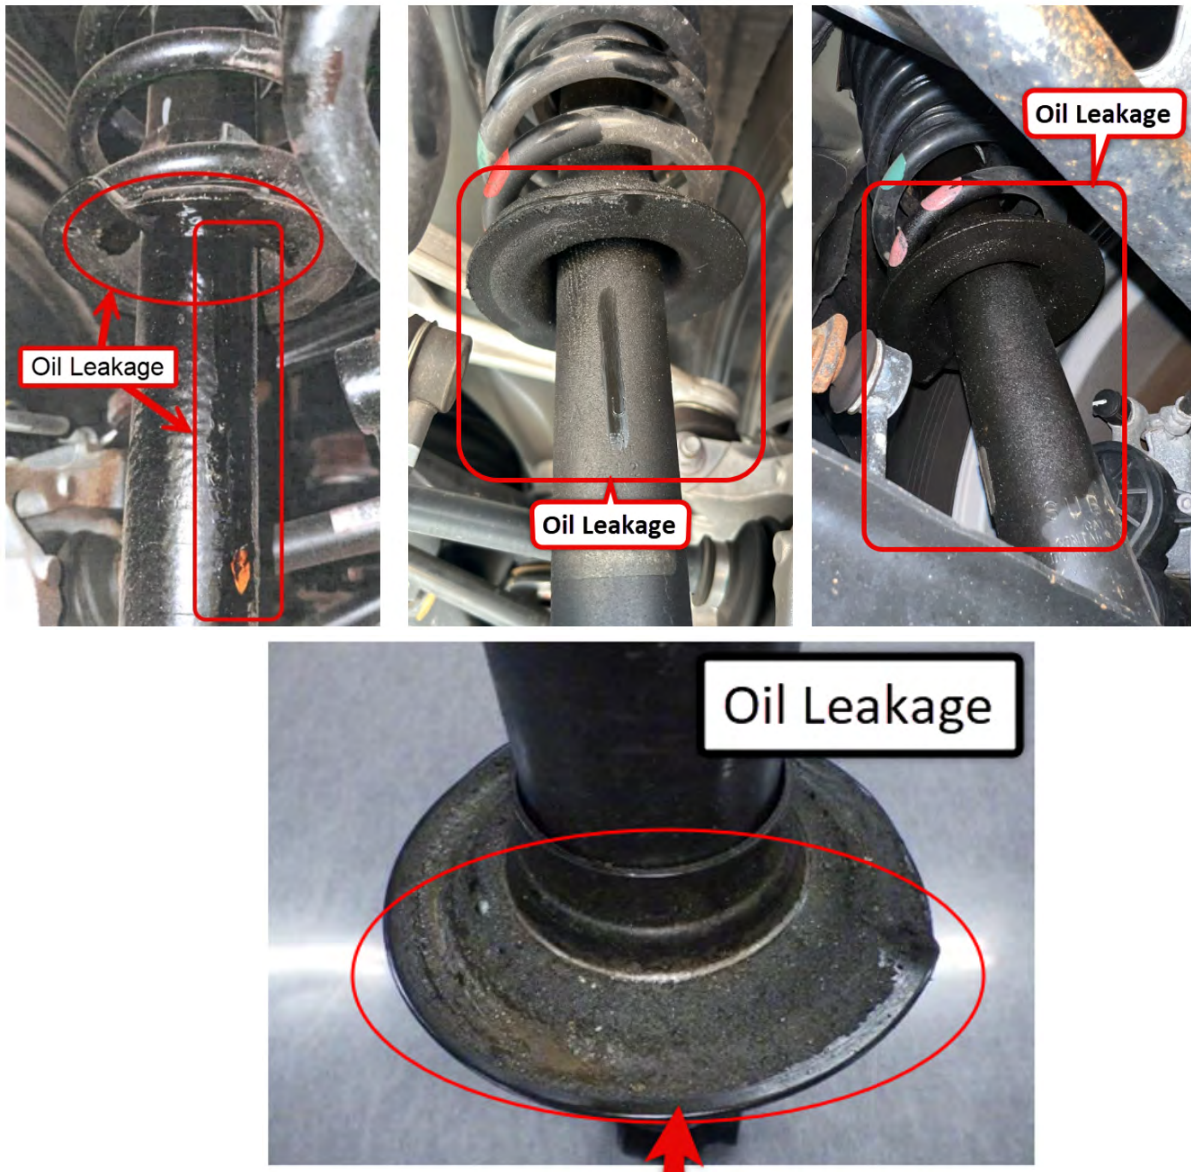
## OIL LEAKAGE:

Oil located below the spring seat is considered excessive and indicates a leaking condition. In these cases, the affected strut will require replacement. See the example images of leaking shocks below.
