SERVICE BULLETIN

APPLICABILITY: 2017-18MY Impreza
 2018MY Crosstrek
 2018MY Legacy and Outback
 2018MY BRZ*

NUMBER: 15-211-17R

SUBJECT: Reprogramming File Availability for Additional Optimization of Harman Gen 3 Audio and Navigation Head Units

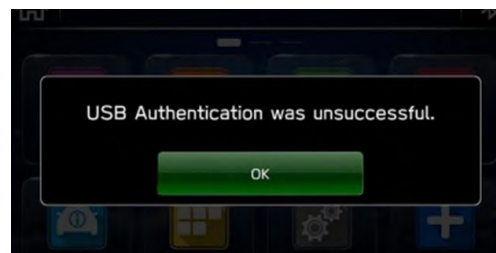
CAUTION: NEVER attempt to install this software on any 2019 MY vehicles as they are equipped with Gen 3.1 Audio/ Navigation systems. This update is **ONLY** for models equipped with Gen 3.0 Audio/ Navigation systems. Should an attempt be made to install any of these files into a Gen 3.1 head unit, the authentication error screen to the right will be displayed.

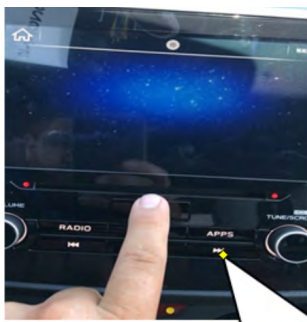
Background shown, but no icons

- On 2018MY Legacy / Outback models with Navigation (High) head units, the update corrects a condition where the head unit remains powered even after the ignition is OFF and the driver door is opened.
- Update for a condition where the SXM presets become lost and only “Initializing” appears as shown below.
- Update for condition where only the star field background is displayed (without icons) after the HOME button is pressed.

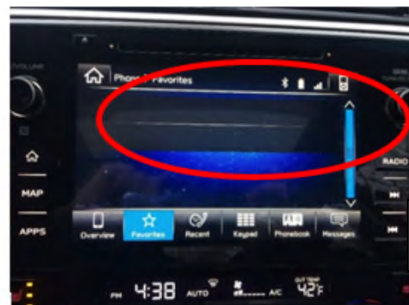
List is blank

- Update for a “Pop” or “Crackling“ sound concern when listening to AM radio.
- Update for a concern of the head unit continually resetting itself.
- Update for a concern of after selecting a contact to be a “Favorite” and the “Favorite” list display is blank.

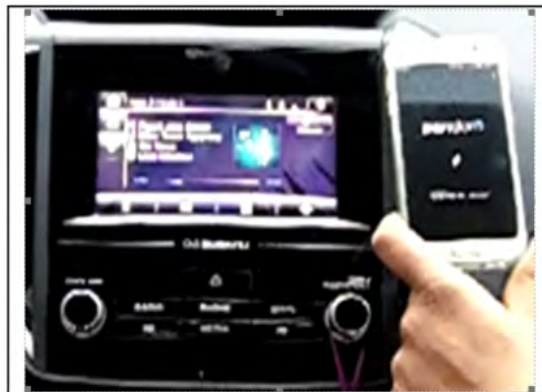
- 1- No streaming audio; when using the Pandora® app, there is no audio output.

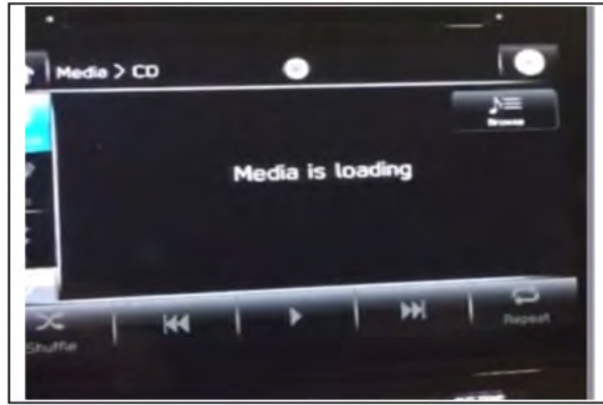
- 2- "Media is loading" is displayed on the screen but, the media never completes loading.

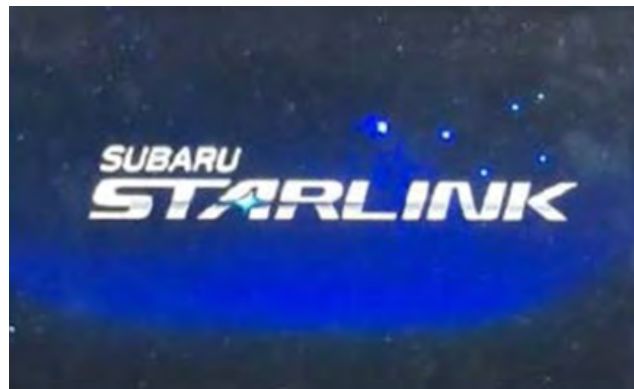
- 3- The screen freezes when the STARLINK screen is displayed.

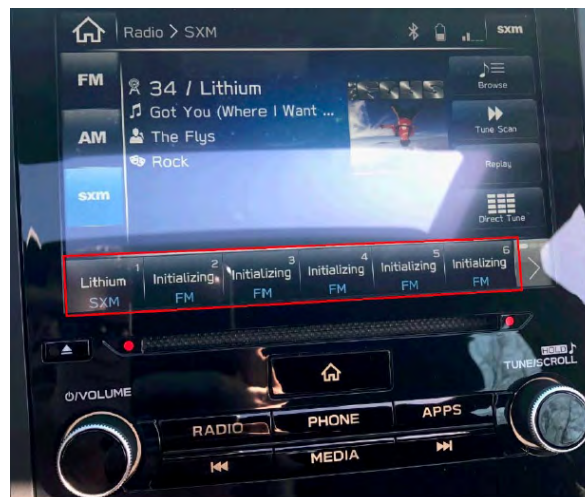
- 1- Radio station presets disappear (touch screen buttons return to "Initializing").

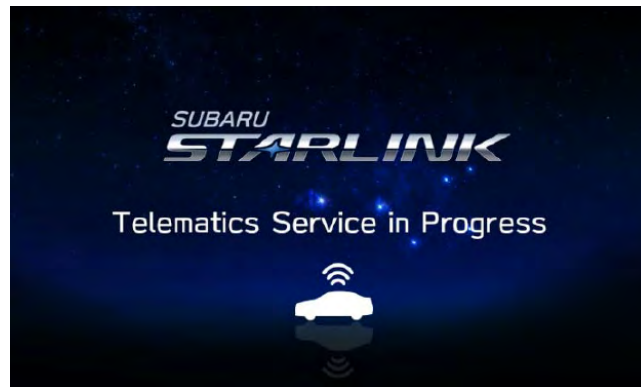
2- STARLINK “Telematics Service in Progress” screen freezes.

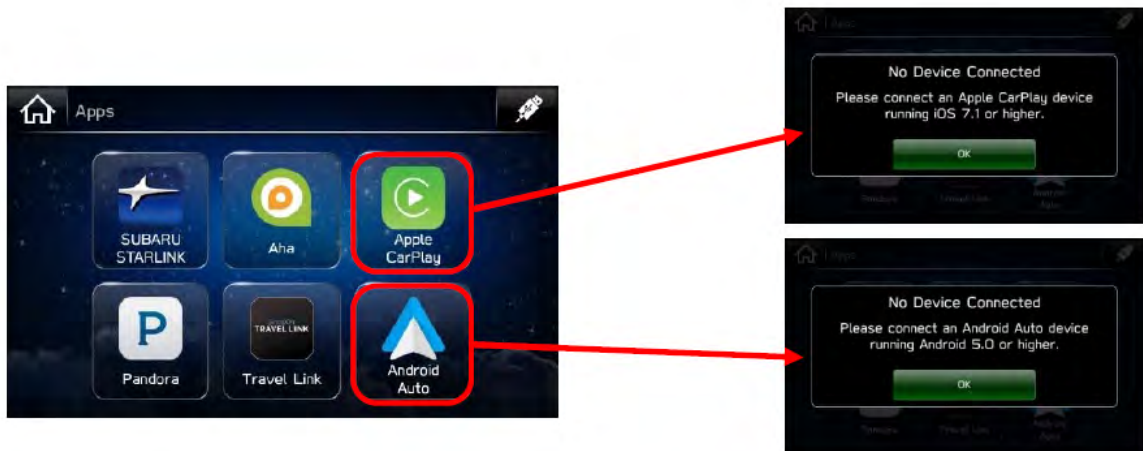
3- Apple Car Play / Android Auto function does not operate (“No Device Connected”).

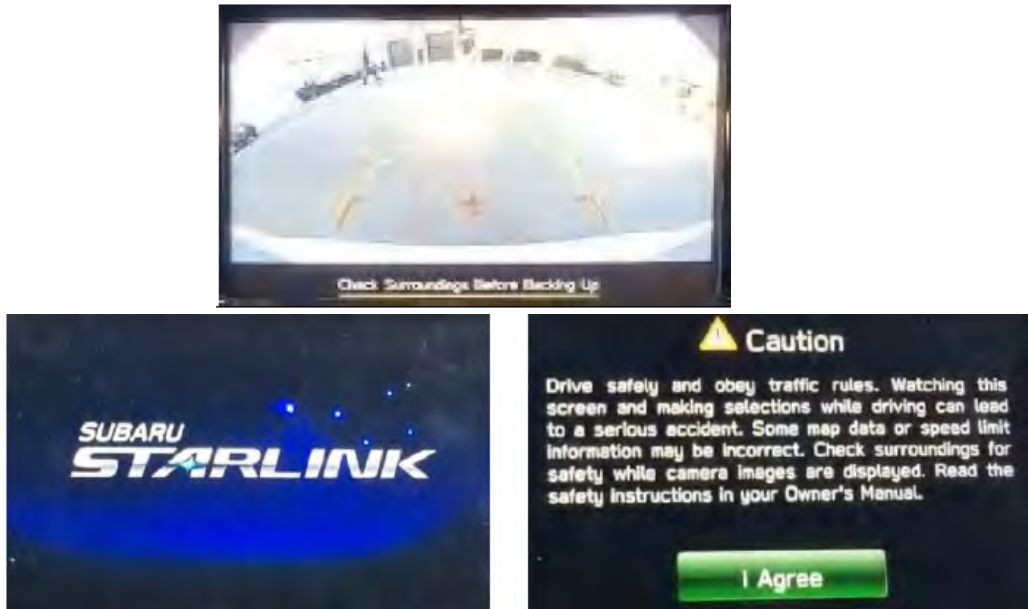
For reference, the previously released WTN-74R symptoms are also provided below. The main purpose of WTN-74R was to address display screen freeze-up during Back-Up Camera display (when the shifter is in “R”). In addition, the screen may also freeze when either the Subaru STARLINK or Disclaimer Caution / I Agree screen is displayed.

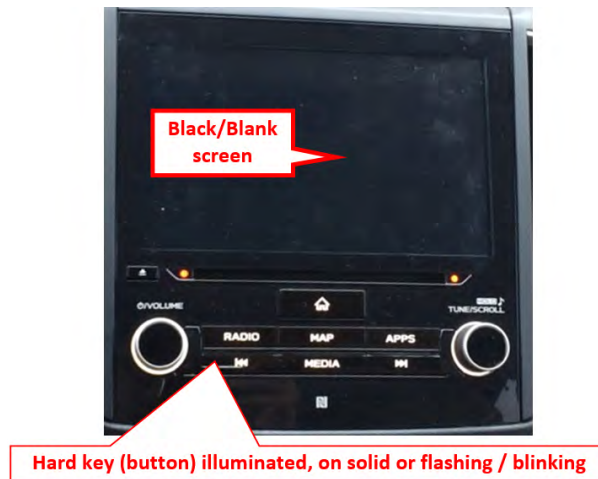
- 1) After switching the vehicle (ACC or IGN) on, the display screen goes black with no audio output and the hard key buttons are illuminated (on solid, or flashing / blinking).

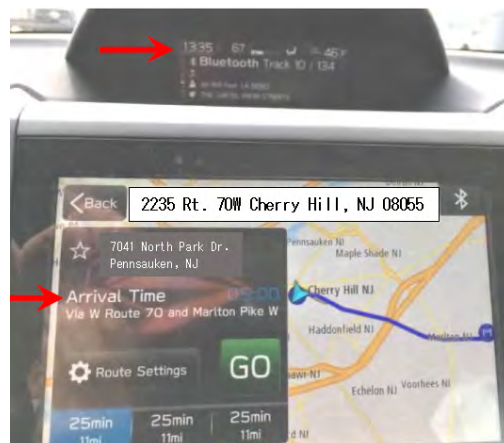
- 2) Time of day displayed in the MFD is incorrect and the arrival time displayed in Navigation unit is also incorrect.

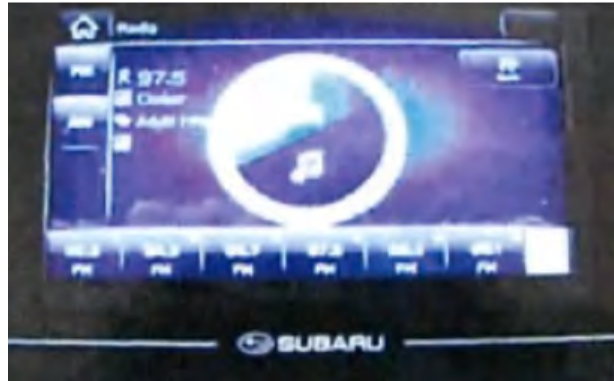
- 3) The time in the MFD automatically reverts to a “default” setting, even after setting the time using “Manual” mode.
- 4) Audio volume goes to maximum automatically after one click of the volume up button on the steering wheel. In some cases, this condition may also occur without input from the operator. Maximum volume is also displayed on the screen.
