SERVICE BULLETIN

APPLICABILITY: 2019-23MY Impreza
 2019-23MY Crosstrek (Including Hybrid Model)
 2019-24MY Forester
 2019MY Legacy/ Outback
 2019-21MY WRX
 2019-21MY WRX STI
 2019-21MY BRZ- Navigation -equipped ONLY
 2019-22MY Ascent

NUMBER: 15-236-18R

SUBJECT: Reprogramming File Availability for Optimization of Harman Gen 3.1 and Gen 3.1α Audio and Navigation Head Units

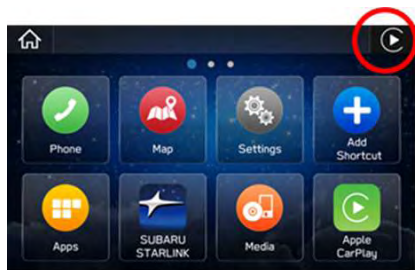
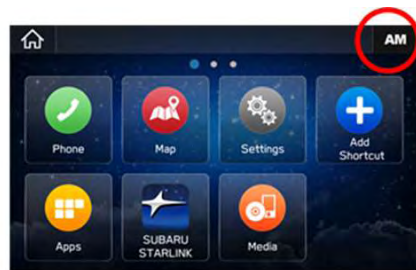
On Ver. 6.0 and before:

Music playing via iPhone in CarPlay.

After disconnecting, the music source changes to Radio automatically.

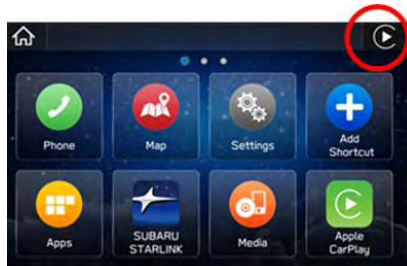
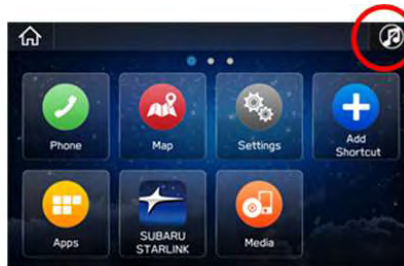
Music playing via iPhone in CarPlay.

After disconnecting, no music source is selected automatically.

If a source of music other than CarPlay has been playing when the iPhone is disconnected, the music source remains same (it is not turned off.)

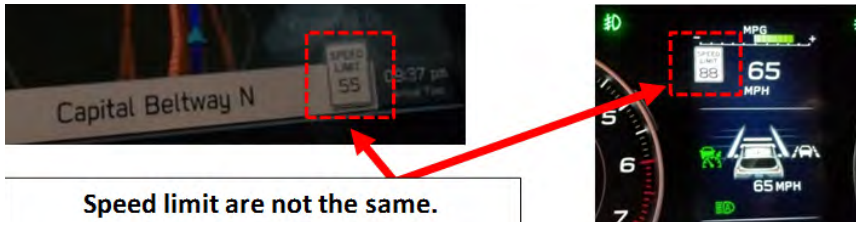
- 12) Mismatch of Speed Limit between Navigation display and the Speed Limit displayed in the Combination Meter Multi-Function Display (MFD).

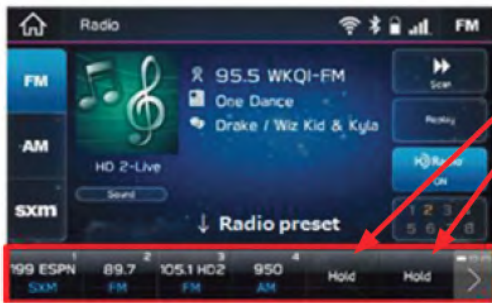
- 1) Station presets are lost. Touch buttons read “Hold”. (Applicable for software versions Rel_4.18.25.50 (or before)). Included in software version Rel_U1.18.38.50.
