SERVICE BULLETIN

APPLICABILITY: All Telematics Equipped Models
Except Solterra

NUMBER: 15-308-23R

SUBJECT: Diagnostic Information - Testing Telematics Systems for Dark/Standby Current

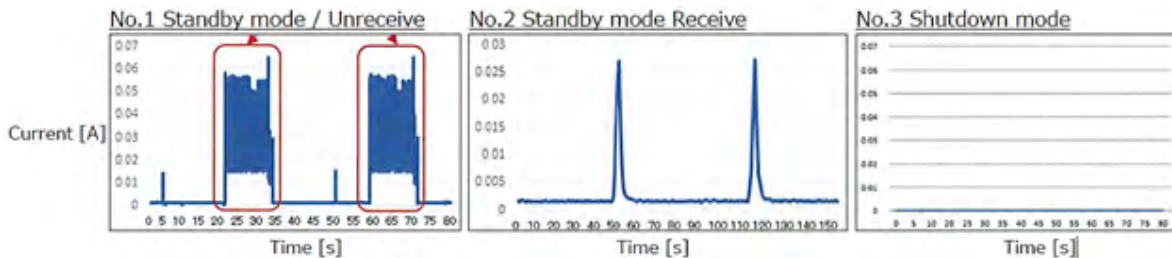
The DCM has six possible states of amperage current waveform patterns. The DCM will shut down after a 15-day time period without the ignition being turned on. During Factory Mode (*) the DCM will shut down after approximately 30 seconds. When the DCM cannot receive a radio wave signal, it will attempt to find a signal once a minute causing an increase in current draw (detailed in **red** below).
