**SERVICE PROGRAM BULLETIN**

**APPLICABILITY:** 2023MY Solterra

**NUMBER:** WRB-24

**SUBJECT:** Forward Recognition Camera Reprogramming

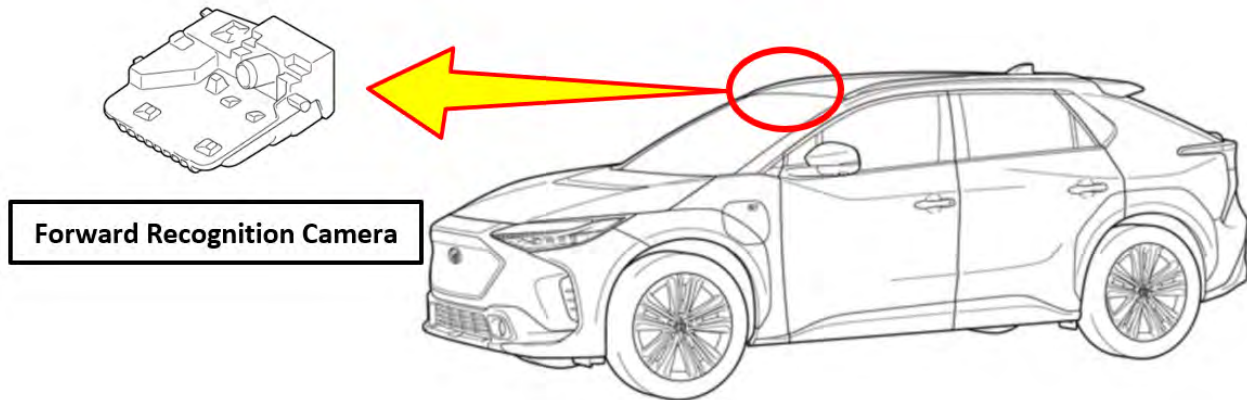
The subject vehicles are equipped with SUBARU Safety Sense which utilizes a Forward Recognition Camera to detect objects for certain driver assistance features including the Pre-Collision System (PCS). Due to the programming of the camera software, there is a possibility the memory of the camera could fail during processing when the ignition is turned OFF. If this occurs, the PCS will not activate on the next ignition start causing warning lights to illuminate, audible chimes to sound and messages to display on the instrument panel.

Subaru retailers will update the Forward Recognition Camera software at no cost to the customer.
