SERVICE BULLETIN

APPLICABILITY: 2019-24MY Ascent **NUMBER:** 06-92-24

SUBJECT: Front Brake Pulsation/Squeal Diagnosis &

Repair Front Brake Warranty Extension

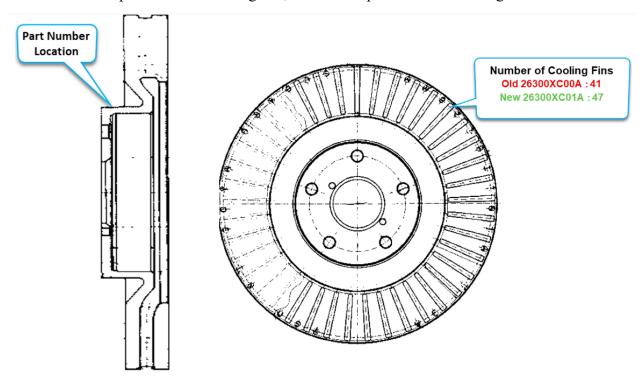
STEP 2: Raise the vehicle using the lift manufacturer's specified procedures. Remove both front wheels. Inspect the brake disc part numbers to confirm the brake disc version currently installed on the vehicle. See the images below for part number location.

NOTE: The new parts have 47 cooling fins, and the old parts have 41 cooling fins.

YES: Resurface the brake discs using a Subaru approved brake lathe. Perform a road test and confirm there in no front brake squeal/pulsation. **IMPORTANT: ALWAYS** use an approved brake lathe. A list of approved equipment can be found on the Subaru tools and equipment site: https://subaruretailersolutions.com/equipment/category/601

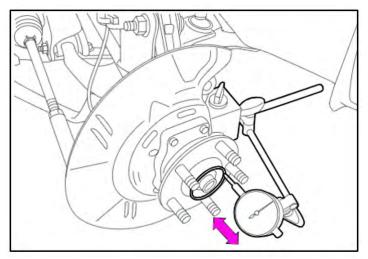
STEP 7: Using a dial gauge, inspect for any excessive play in the axial direction of the front hub bearing. Confirm the observed measurement is below the service limit of 0.05mm (0.002 in). If the measurement exceeds the specified value, the front hub bearing will require replacement.

*NOTE: Noise or judder caused by excessive play on the front hub bearing is a separate condition that is not covered under the terms of this warranty extension. Please process such repairs under normal procedures.

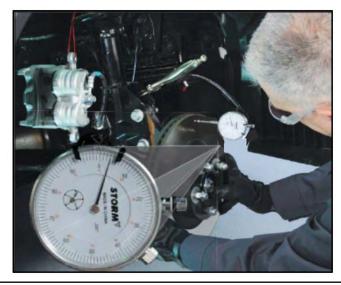
STEP 8: Install the new brake disc. Secure the disc to the hub using the five lug nuts in conjunction with matching suitable washers. Torque the lug nuts in a star pattern to 120 Nm (88.5ft-lb). Using a dial gauge, inspect the outer brake disc runout. Confirm the observed measurement does not exceed 0.05 mm (0.002 inch). If the measurement exceeds the specified value, remove the brake disc from the hub. Using the wheel studs as a guide, rotate the disc clockwise one wheel stud position and reinstall the brake disc. Inspect the runout using the procedures described above. The brake disc position can be rotated up to 4 more times to confirm the position with the least amount of runout. Install the brake disc at this position. In rare cases of the measurement not reading within specification after the five position inspection, exchange the brake disc the other side of the vehicle and repeat the measurement. If the measurement continues to produce results out of specifications, replace the brake disc.

IMPORTANT: For best accuracy, the runout measurement should be taken 10mm from the outer circumference of the brake disc. See the example image below.
