| TSIB 22-13 Rev B | | July 9th, 2024 |
| TITLE: | Torque value change to splined joint on the upper steering shaft. | |
| APPLICABILITY: | New Flyer Xcelsior buses equipped with double tilt steering columns & upper steering shaft New Flyer part number 532703. | |

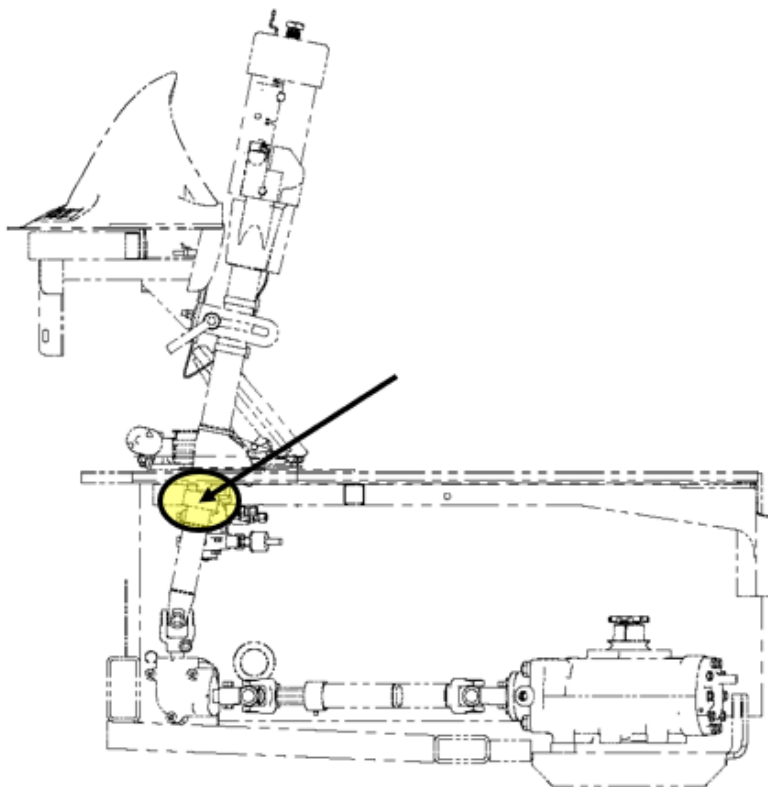
**Figure 1: Location to Torque on Upper Steering Shaft**

This TSIB will provide an updated recommendation for torque of hardware used to secure the splined joint in on the upper steering where it joins to the steering column.

For customers operating New Flyer Xcelsior buses equipped with double tilt steering columns, it is New Flyer's recommendation that, at the next maintenance interval, the torque in the location depicted in the diagram be increased from 50 ft-lb to 70 ft-lb  $\pm$  4 ft-lb.
