BULLETIN NUMBER:
IB16-F-001D

LIMITED SLIP DIFFERENTIAL CHATTERING NOISE

- 2011-2022MY Isuzu N-Series Vehicles
Equipped with 5.2L (4HK1) Diesel Engine **and** Limited Slip Differential (LSD)
Option Code IV0
- 2020- 2025MY Isuzu N-Series Vehicles
Equipped with 6.6L (L8T) Gasoline Engine **and** Limited Slip Differential (LSD)
Option Code IV0
- 2022MY Isuzu N-Series Vehicles
Equipped with 6.0L (PSI) Gasoline Engine **and** Limited Slip Differential (LSD)
option code IV0

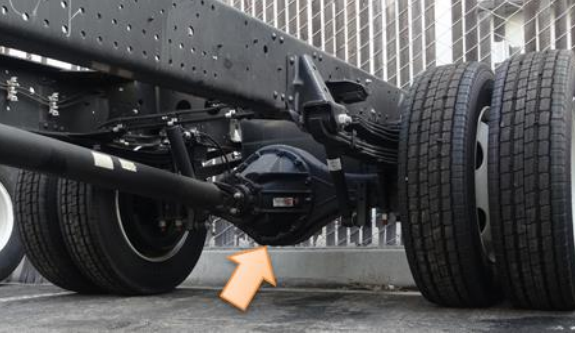
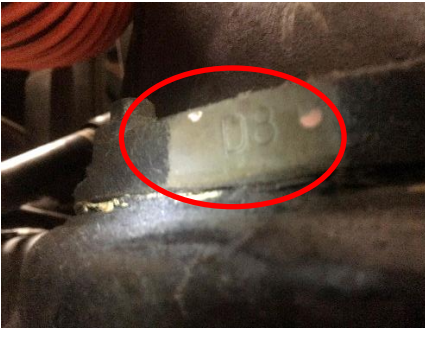
<p>LSD Stamp</p> <p><u>Codes</u></p> <p>B7</p> <p>D0</p> <p>D8</p> <p>D9</p> <p>H0</p> <p>H1</p> <p>H9</p>
<p>Figure 1 – Code Location</p>	<p>Figure 2 – Example of Stamping</p>

See Figures 1 and 2 below in this bulletin to identify a limited slip differential or check the vehicle build in IVIS (Isuzu Vehicle Information System) for Option Code IV0.
