<b>REFERENCE:</b>	<b>TSB:</b> 08-172-24 <b>GROUP:</b> 08 - Electrical	<b>Date:</b>	July 31, 2024	<b>REVISION:</b>	08-049-22						
<b>VEHICLES AFFECTED:</b>	<b>2022 - **2023** (MP) Jeep Compass</b> <b>This bulletin applies to vehicles built on and before **August 14, 2023 (MDH 0814XX)** equipped with one of the following radios:</b> <ul style="list-style-type: none"> <li>● Uconnect 5 W 10.1" Display (Sales Codes UBU, UEU, UPU and UFU).</li> <li>● Uconnect 5 W 8.4" Display (Sales Codes UBE, UEE, UPE and UFE).</li> </ul>			<b>MARKET APPLICABILITY:</b>

This bulletin supersedes Technical Service Bulletin (TSB) 08-049-22, date of issue March 09, 2022, which should be removed from your files. All revisions are highlighted with **\*\*asterisks\*\*** which include updated symptoms, vehicle clean date, model year and new LOPs.

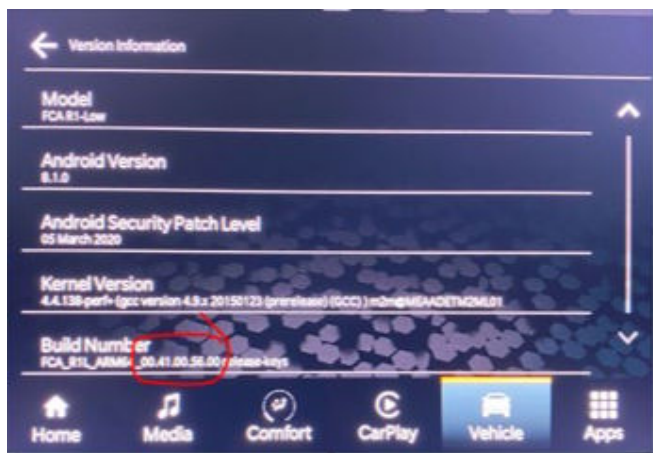
**Fig. 1**  
Software Version

1. Verify the software version by following these steps:
  - On the radio display screen go into “Vehicle Settings”
  - Select “System Information”. Select “Version Information”.
  - Under the “Build Number”, radio software version is listed. For example, the software version here is 00.41.00.56.00 [Fig. 1](#).

**NOTE:** If the radio software is at or above R34.00.49 and under R41.00.56 the radio will need two USB flash drives to update the radio. This means that, for example, if the radio is at R34.00.49, it will need to be updated to R41.00.56 first and R47.03.26 as a second step.
