<b>REFERENCE:</b>	<b>TSB:</b> 08-173-24 <b>GROUP:</b> 08 - Electrical	<b>Date:</b>	July 31, 2024	<b>REVISION:</b>	-
<b>VEHICLES AFFECTED:</b>	<p><b>2022 - 2023 (VF) RAM Promaster</b>  <b>2022 - 2023 (D2) RAM 3500 Pickup</b>  <b>2022 - 2023 (DD) RAM 3500 Cab Chassis</b>  <b>2022 - 2023 (DF) RAM 3500 10k Lb. Cab Chassis</b>  <b>2022 - 2023 (DJ) RAM 2500 Pickup</b>  <b>2022 - 2023 (DP) RAM 4500/5500 Cab Chassis</b>  <b>2022 - 2023 (DT) RAM 1500 Pickup</b>  <b>2022 - 2023 (MP) Jeep Compass</b></p> <p><b>This bulletin applies to vehicles equipped with one of the following:</b></p> <ul style="list-style-type: none"> <li>• Uconnect 5 NAV W 10.0" Display (Sales Codes UBN or UEN) with a Global Telematics Box Module (Sales Code RDG).</li> <li>• Uconnect 5 NAV W 8.4" Display (Sales Codes UBL or UEL) with a Global Telematics Box Module (Sales Code RDG).</li> <li>• Uconnect 5 NAV W 12.0" Display (Sales Codes UBQ and UEQ) with a Global Telematics Box Module (Sales Code RDG).</li> </ul>			<p><b>MARKET APPLICABILITY:</b></p> <p><input checked="" type="checkbox"/> NA                      <input type="checkbox"/> MEA  <input type="checkbox"/> SA                         <input type="checkbox"/> IAP

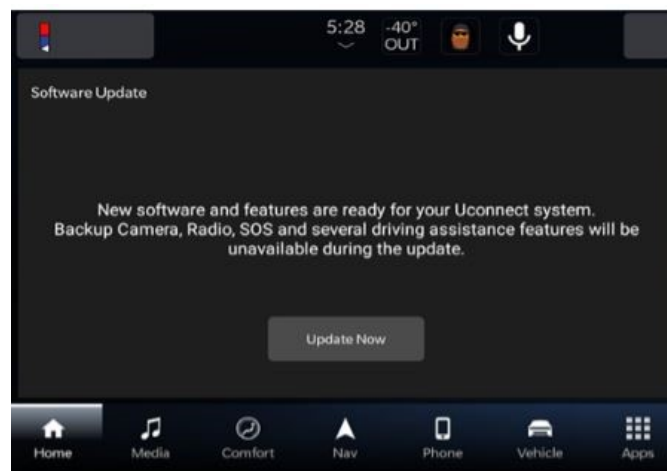
**Fig. 1**

#### Software Acceptance Screen

1. The vehicle needs to be in 'Park'. The ignition needs to be in the off position.
2. If the customer selects "Update Now" [Fig. 1](#) they can shut off the vehicle and leave. The update will be completed automatically.

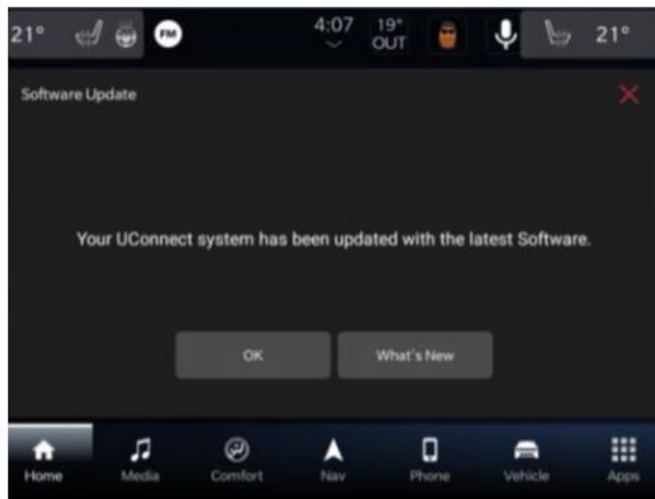
**Fig. 2**  
Software Update Confirmation Screen

3. Upon completion of update, the radio will display a confirmation message [Fig. 2](#).
