Oil Leakage in the Area of the Upper Part of the Oil Pan and Crankcase: Checking Return Seal on Upper Part of Oil Pan and Replacing if Necessary (91/24)

Vehicle Type: **911 Carrera (992) / 911 Carrera S (992) / 911 Sport (992) / 911 Carrera GTS (992) / 911 Carrera T (992) / 911 Carrera 4 (992) / 911 Carrera 4S (992) / 911 Carrera 4 GTS (992) / 911 Targa 4 (992) / 911 Targa 4S (992) / 911 Targa 4 GTS / 911 Turbo (992) / 911 Turbo S (992) / 911 Dakar (992)**

Model Year: **As of 2020 up to 2024**

Concerns: **Oil pan return seal**

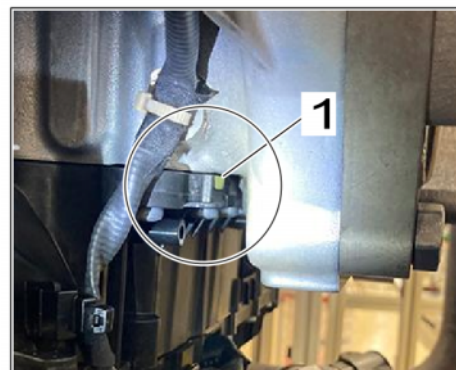
Oil leakage area

Cause: **Oil traces are detected on the oil pan on the side of the engine transmission flange.**

The leak is located in the area of the sealing point between the upper part of the engine oil pan and crankcase ⇒ *Oil leakage area -Circle-*, on green return seal ⇒ *Oil leakage area -1-* in the “window section” of the upper part of the oil pan.

Replacing the upper part of the oil pan, including the moulded seal, is not expedient because this complaint involves a defect in the return seal in the area of the “window section” of the oil pan and not a defect in the oil pan itself.

Action: Check the return seal in the area of the “window section” and replace it with a **new component status** if applicable.

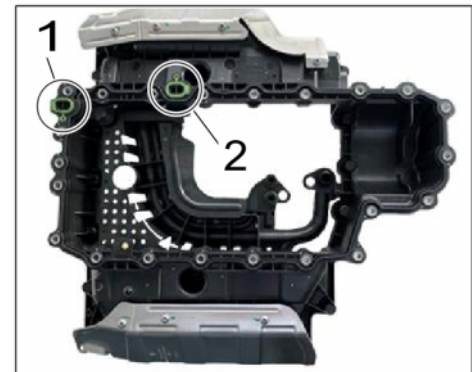
Affected seals

The previous component status of the return seal in green must no longer be used here.

- 3 Replace previous return seals ⇒ *Affected seals -1 and 2-* on the upper part of the oil pan with **new, black return seals with a new component status**.
For procedure, see: ⇒ *Workshop Manual '175019 Removing and installing oil pan (upper part)'*
