**Oil Leakage in the Area of the Upper Part of the Oil Pan and Crankcase: Checking Return Seal on Upper Part of Oil Pan and Replacing if Necessary (91/24)**

Vehicle Type: **718 Cayman GTS 4.0 (982) / 718 Boxster GTS 4.0 (982) / Boxster 25 years (982) / 718 Spyder (982) / 718 Cayman GT4 (982)**

Model Year: **As of 2020 up to 2024**

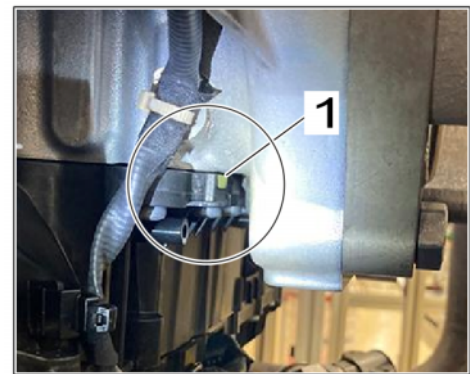
*Oil leakage area*

Cause: **Oil traces are detected on the oil pan on the side of the engine transmission flange.**

The leak is located in the area of the sealing point between the upper part of the engine oil pan and crankcase ⇒ *Oil leakage area -Circle-*, on green return seal ⇒ *Oil leakage area -1-* in the "window section" of the upper part of the oil pan.

Action: Check the return seal in the area of the "window section" and replace it with a **new component status** if applicable.

**Replacing the upper part of the oil pan, including the moulded seal, is not expedient** because this complaint involves a defect in the return seal in the area of the "window section" of the oil pan and not a defect in the oil pan itself.

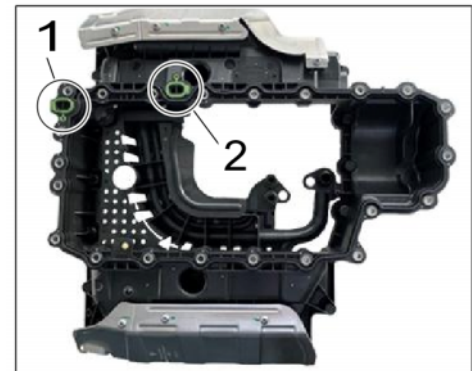
*Affected seals*

The previous component status of the return seal in green must no longer be used here.

- 3 Replace previous return seals ⇒ *Affected seals -1 and 2-* on the upper part of the oil pan with **new, black return seals with a new component status**.  
 For procedure, see: ⇒ *Workshop Manual '175019 Removing and installing oil pan (upper part)'*
